SIB 33 02 24

SERVICE ACTION: Checking Rear Drive

2024-03-18

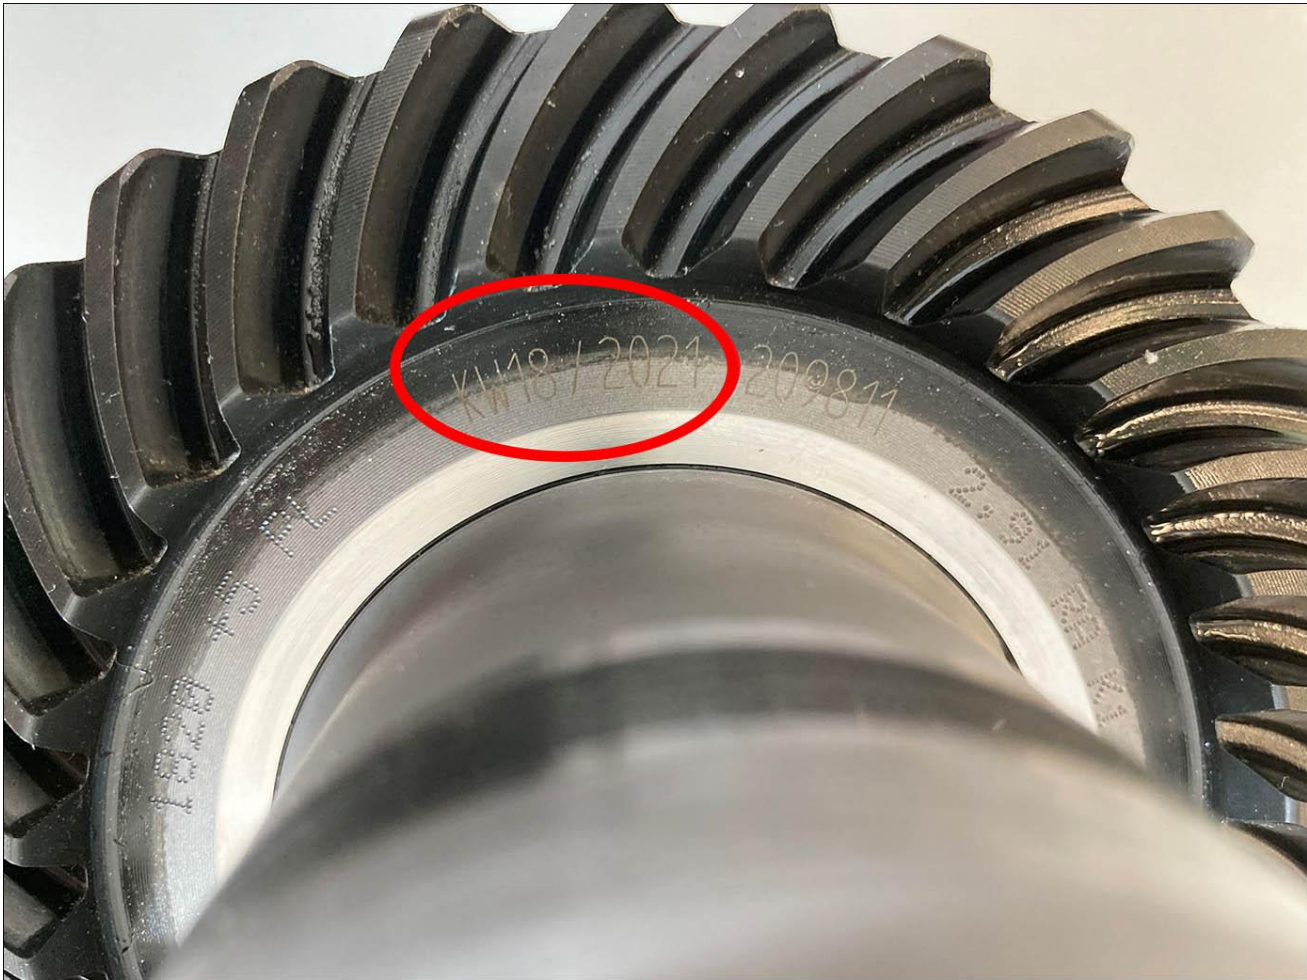
If the production date is "KW 18/2021" the Rear drive must be replaced according to repair instructions "33 74 529 – Replacing bevel gears rear (with testing)".
