TECHNICAL SERVICE BULLETIN

Technical Service Bulletin: 210-1746

Forest River is alerting you to an issue involving certain 2023-2024 Concord & Entourage & 2023-2025 Freelanders & Leprechaun Class C Motorhomes Recreational Vehicles. Please see the information below, which describes the issue and provides you with details on the steps you should take to have your vehicle repaired.

TECHNICAL SERVICE BULLETIN 210-1746 REMEDY INSTRUCTIONS

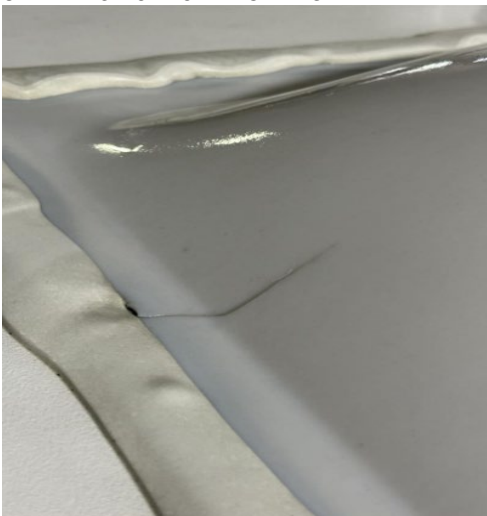
SAMPLE OF CRACKED SKYLIGHT

A limited number of outer dome skylights have displayed cracks soon after installation. Cracks may originate at the flange of the skylight and extend outward.

Make(s): MANY, SEE BELOW Model(s): MANY Model Year(s): 2023 - 2025	Repair Code: SB-460-01-00-004522 Allotted Time: 1.00 HRS. Inspection Code: SB-460-05-00-004521 Allotted Time: .10
	Concern: A limited number of skylights have displayed cracks soon after installation or may develop after time.	Photo(s) Required: YES Prior Authorization Required: YES Part(s) Number: SEE BELOW Part(s) Return: NO, FIELD DESTROY

STEP 1: REMOVE THE INNER SKYLIGHT COVER AND ROOF TOP SKYLIGHT DOME;

STEP 2: CLEAN THE ROOF TOP OPENING OF THE DOME AREA OF ANY DEBRIS/SEALANT;

STEP 3: ADHERE BUTYL TAPE TO UNDERNEATH OF SKYLIGHT DOME;

STEP 4: INSTALL 1" SCREWS IN ALL OPENINGS OF THE SKYLIGHT DONE;

- DO NOT OVER TIGHTEN THE SCREWS, WHICH MAY CAUSE CRACKING IN THE SKYLIGHT DOME;

STEP 6: APPLY ALPHATHANE 5121 ADHESIVE/SEALANT TO THE SKYLIGHT DOME AND FASTENERS;

- ENSURE TO SEAL THE SKYLIGHT DOME COMPLETELY AROUND ITS PARAMETER;

STEP 7: INSTALL REPLACEMENT INTERIOR SKYLIGHT COVER;
