CADILLAC  
DCS6838  
URGENT - DISTRIBUTE IMMEDIATELY

Subject: UPDATE: N232428540 - Customer Satisfaction Program  
Multiple Module Reprogramming  
Population Expansion

Models: 2023 Cadillac LYRIQ

## N232428540 Multiple Module Reprogramming

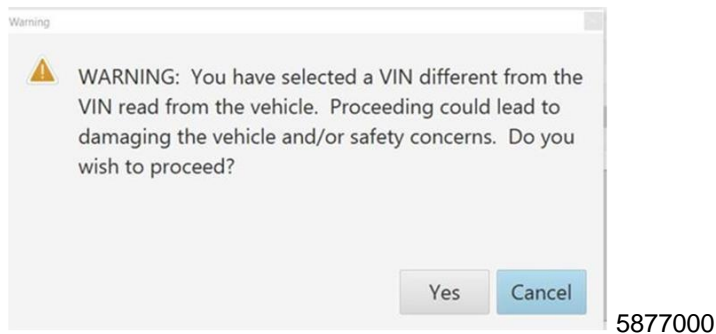
**Important:** If the vehicle VIN DOES NOT match, the message below will be shown.
