NUMBER
PI1802Y/Z (Rev 7, 03/22/2024)

PRODUCT IMPROVEMENT CAMPAIGN

**SUBJECT: ENGINE REPLACEMENT INSTRUCTIONS
FOR DTC P1326 (PI1802Y/Z)**

This bulletin provides information related to the Technical Service Bulletin previously published [PI1802](#) titled "Knock Sensor Detection System - ECU Logic Improvement" equipped w/THETA II engine. Specifically, this bulletin provides instructions on which procedures to follow if, after installation of the KSDS, any one of the subject vehicles below returns to the dealer with Diagnostic Trouble Code (DTC) P1326 (Knock Signal Range/Performance).

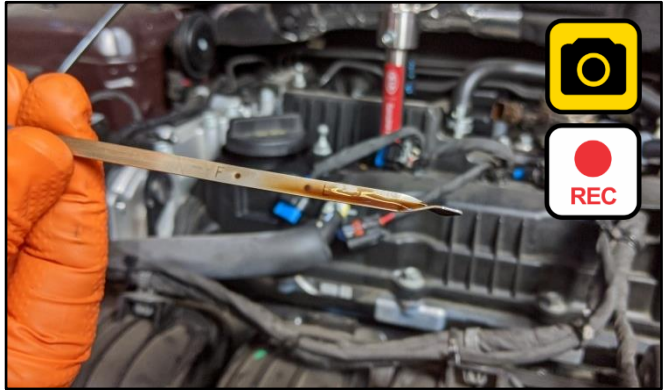
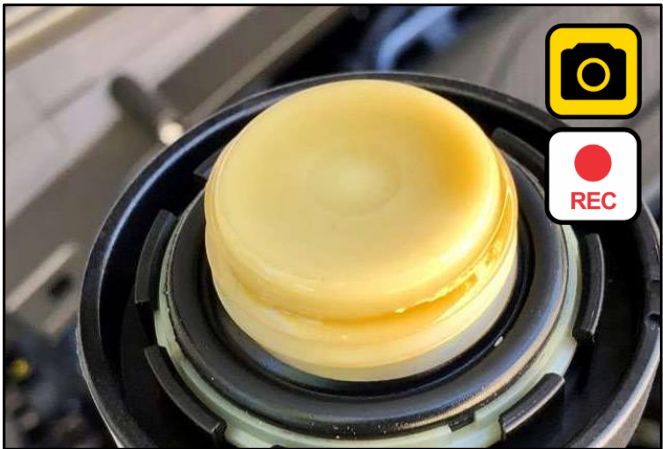
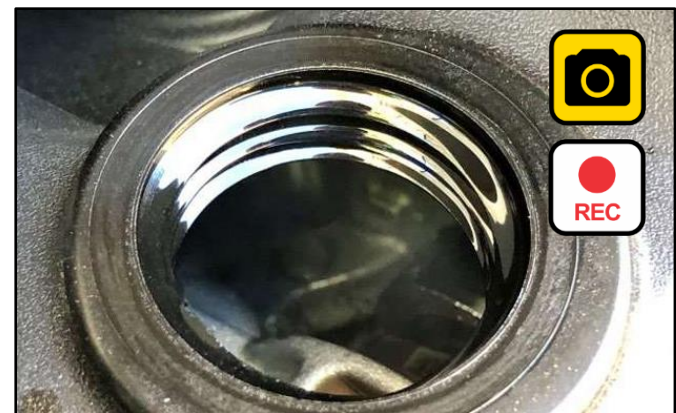
Record/Note findings: No oil, oil sludge, varnish, burnt oil smell condition(s) found.

If NO oil is registered on the dipstick, or oil lacquering, oil sludge and/or oil varnish is present (NG), then the engine is therefore suspect to maintenance neglect. Review of the vehicle's maintenance history is required.

If suspect, proceed to the 'Oil Level Measurement' instructions below **and** submit with the Techline case.

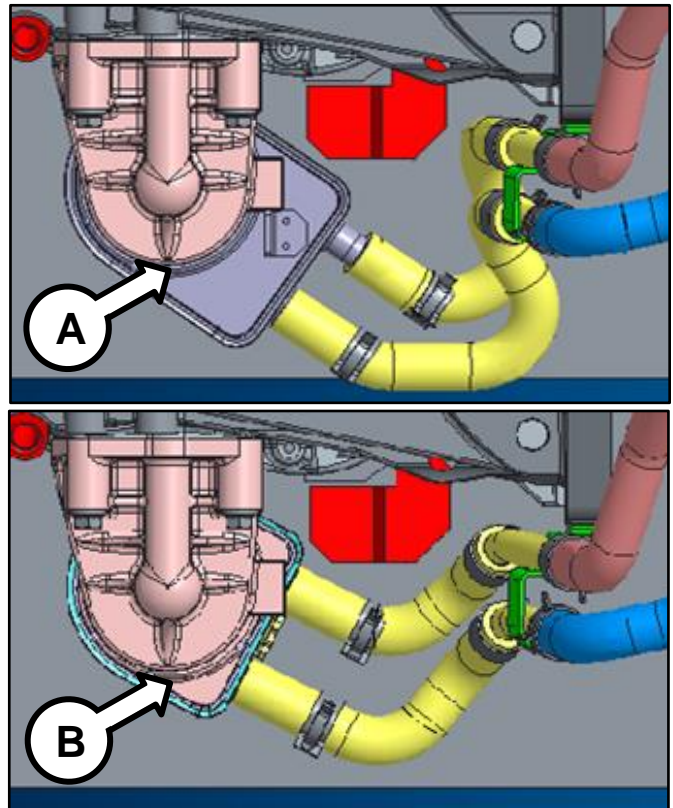
New engines may be supplied with a different oil cooler. Use steps below to determine the need for a replacement oil cooler tube assembly.

- If the new engine's (bigger) oil cooler (A) does not match the old engine's (smaller) oil cooler (B), replace the oil cooler tube assembly with the improved part. See parts table on page 16.
- If the new engine's (bigger) oil cooler (A) matches the old engine's (bigger) oil cooler (A), reuse the old engine's oil cooler tube assembly.
- If the new engine's (smaller) oil cooler (B) matches the old engine's (smaller) oil cooler (B), reuse the old engine's oil cooler tube assembly.
