NUMBER  
PI1803Y/Z (Rev 7, 03/22/2024)

## PRODUCT IMPROVEMENT CAMPAIGN

### ENGINE REPLACEMENT INSTRUCTIONS FOR DTC P1326 (PI1803Y/Z)

This bulletin provides information related to the Technical Service Bulletin previously published [PI1803](#) titled "Knock Sensor Detection System - ECU Logic Improvement" equipped w/THETA II engine. Specifically, this bulletin provides instructions on which procedures to follow if, after installation of the KSDS, any one of the subject vehicles below returns to the dealer with Diagnostic Trouble Code (DTC) P1326 (Knock Signal Range/Performance).

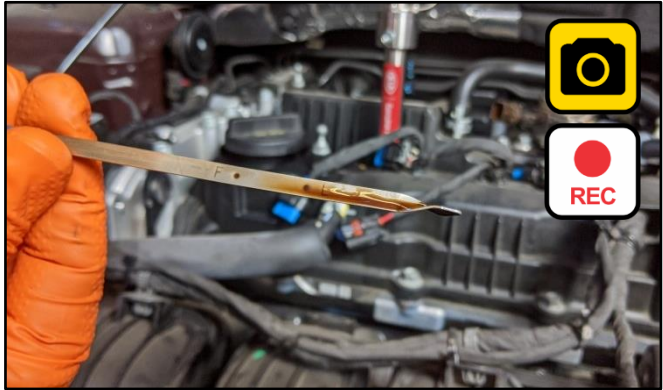
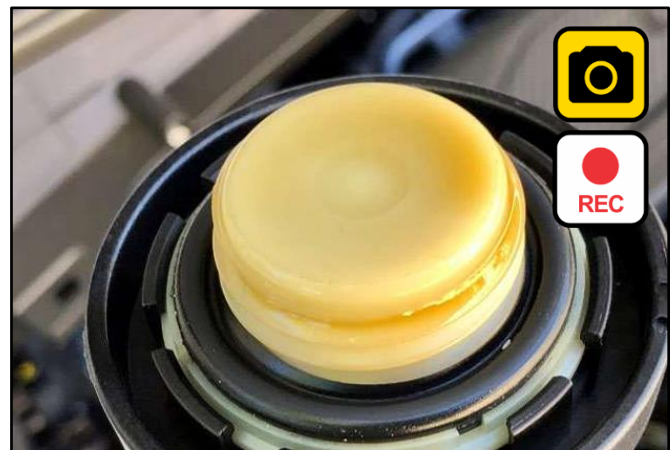
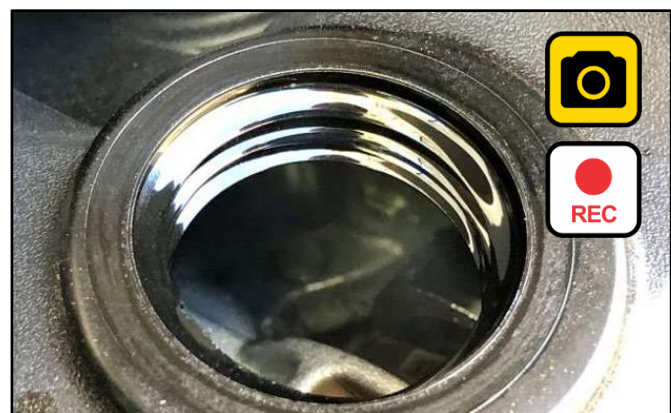
**Record/Note findings:** No oil, oil sludge, varnish, burnt oil smell condition(s) found.

**If NO oil is registered on the dipstick, or oil lacquering, oil sludge and/or oil varnish is present (NG), then the engine is therefore suspect to maintenance neglect. Review of the vehicle's maintenance history is required.**

**If suspect**, proceed to the 'Oil Level Measurement' instructions below **and** submit with the Techline case.

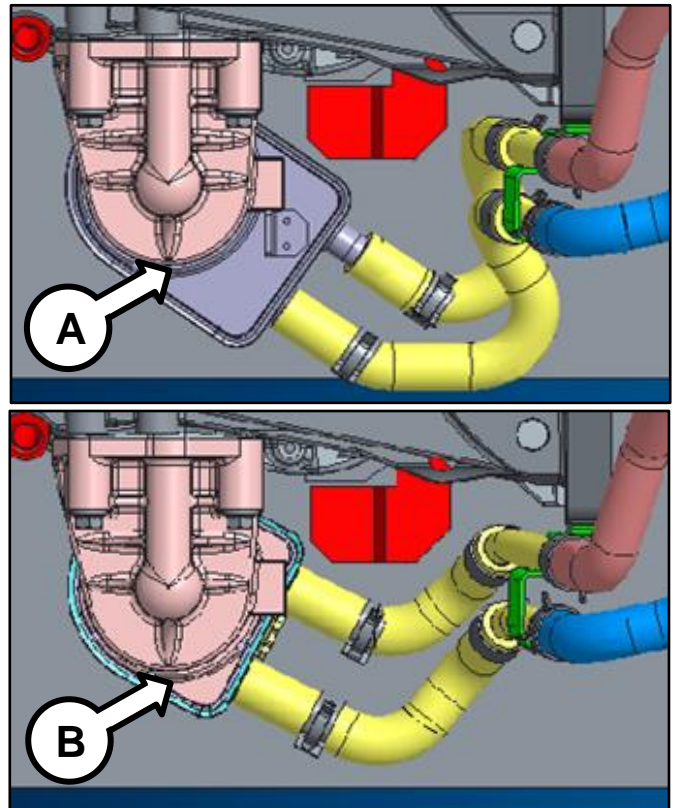
New engines may be supplied with a different oil cooler. Use steps below to determine the need for a replacement oil cooler tube assembly.

- If the new engine's (bigger) oil cooler (A) does not match the old engine's (smaller) oil cooler (B), replace the oil cooler tube assembly with the improved part. See parts table on page 23.
- If the new engine's (bigger) oil cooler (A) matches the old engine's (bigger) oil cooler (A), reuse the old engine's oil cooler tube assembly.
- If the new engine's (smaller) oil cooler (B) matches the old engine's (smaller) oil cooler (B), reuse the old engine's oil cooler tube assembly.

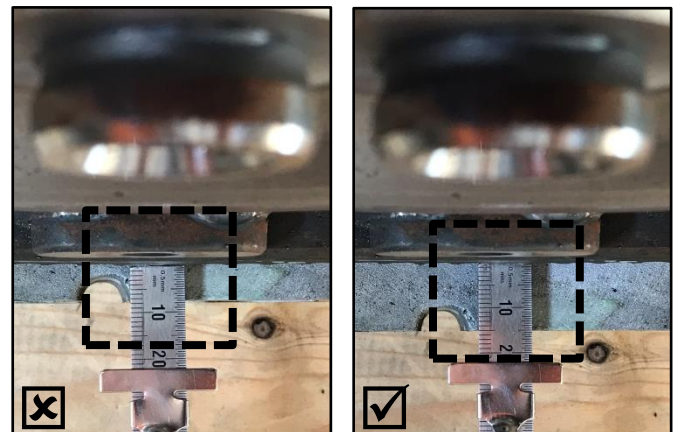
Not Fully Inserted

Fully Inserted

- If the torque converter has moved from the fully inserted position, carefully push inward while rotating the torque converter until it is recessed approximately 9/16 – 5/8" (14 – 16mm) (☑) into the transaxle case when reinstalling the automatic transaxle.
