Technical Service Bulletin

55 Power rear lid not closing fully, rear lid lock not engaging secondary latch position, DTC B113E29, B12E015

55 24 95 2064476/4 March 22, 2024. Supersedes Technical Service Bulletin Group 55 number 24-91 dated February 19, 2024 for reasons listed below.

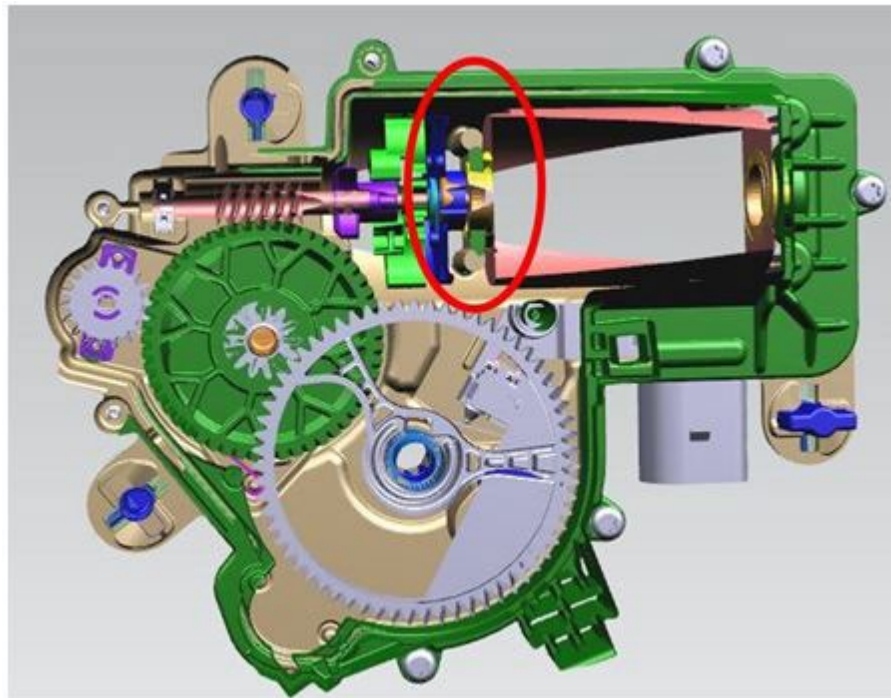
1. The internal clutch of the closing assist motor can be blocked due to a dimensional deviation (Figure 1).

Figure 1. Blocked clutch due to a dimensional deviation.

Replace the rear lid closing assist motor according to the Elsa Repair Manual.

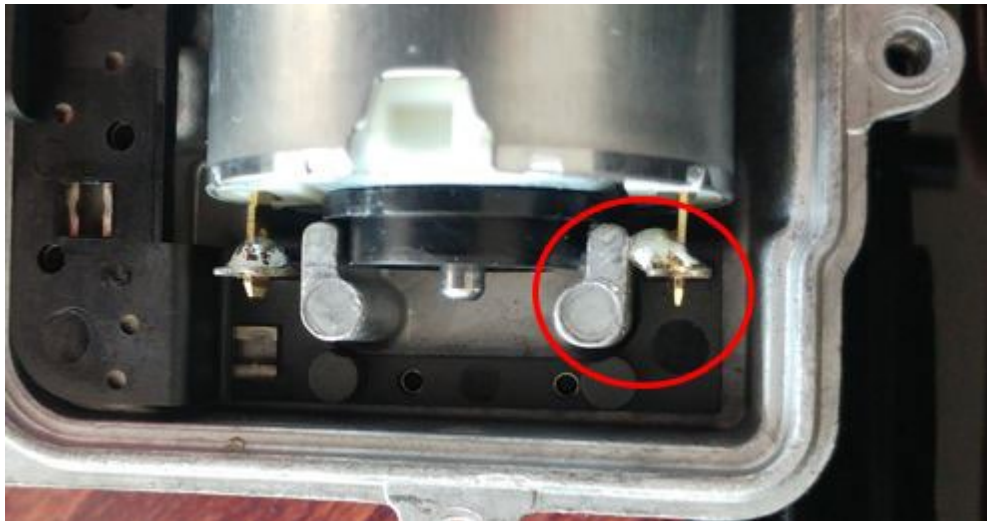
2. An improper solder joint inside the closing assist motor can cause a short circuit. This failure mode could cause DTC B12E015 to store (Figure 2).

Figure 2. Short circuit caused by solder joint.

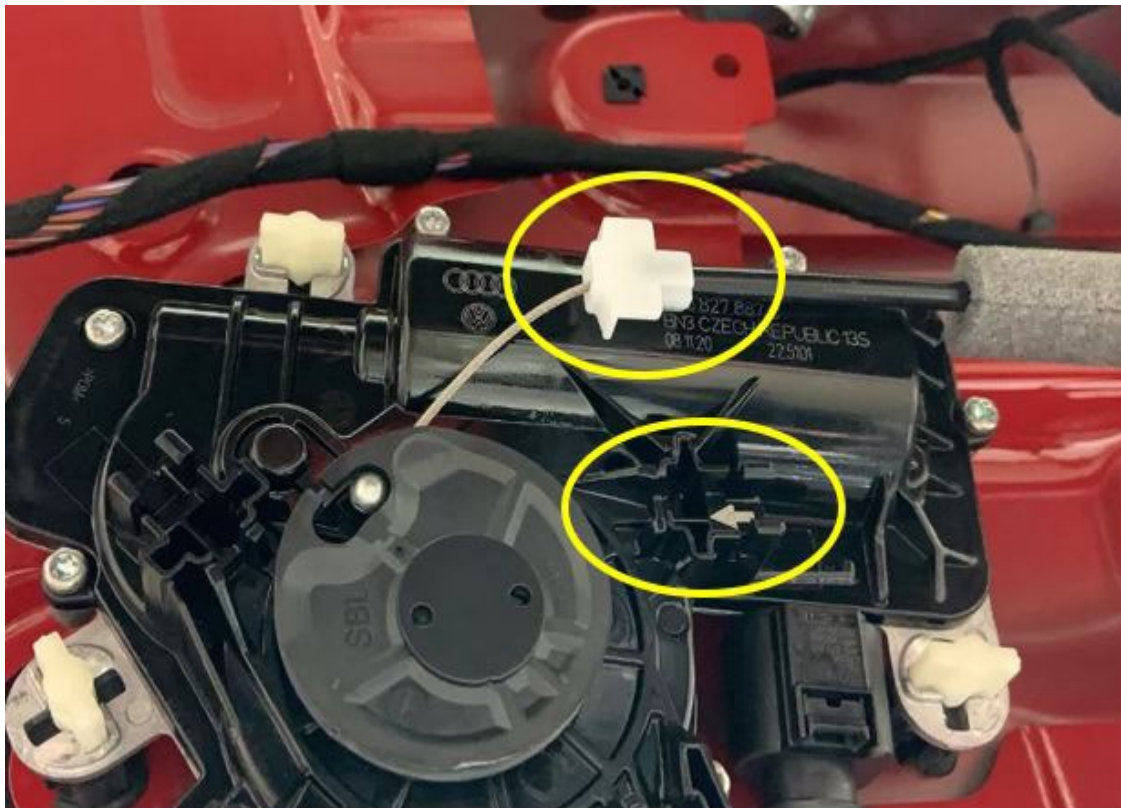
3. The Bowden cable clip has detached from the closing assist motor housing (Figure 3).

Figure 3. Detached Bowden cable clip.
