Technical Service Bulletin

93 Update OBC software when replacing HV wiring harness for charging socket P31D200

93 24 47 2070110/4 March 22, 2024. Supersedes Technical Service Bulletin Group 93 number 23-17 dated July 26, 2023 for reasons listed below.

Model(s)	Year	VIN Range	Vehicle-Specific Equipment
e-tron quattro	2019	All	OBC Cluster 1
e-tron Sportback quattro	2020

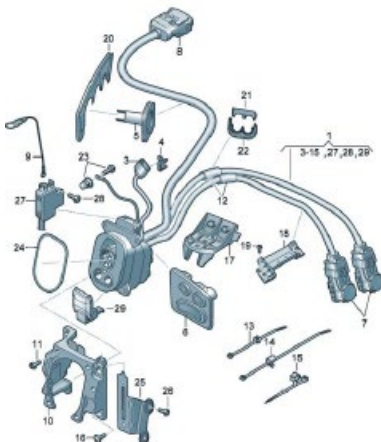
- **P31D200:** “Charge socket A Excessive temperature.”

The High Voltage Wiring Harness for the charging socket UX4 or UX5 is replaced as part of any repair work (Figure 1).

Figure 1. High-voltage wiring harness for charging socket.

If the high-voltage wiring harness for the charging socket is replaced as listed in Table 1.2, an SVM code will need to be performed *and a replacement test plan performed*.

1. Follow all instructions in TSB 2011732: *00 Software Version Management (SVM), operating instructions*.
2. Update the On-Board Battery Charger (J1050) using the SVM action code as listed in the table below, if necessary:
