Service Bulletin

Bulletin No.: 17-NA-106

Subject: Interior Cabin Boom, Vibration and/or Rumbling/Droning Noise Heard While Driving Low Speeds in High Gear

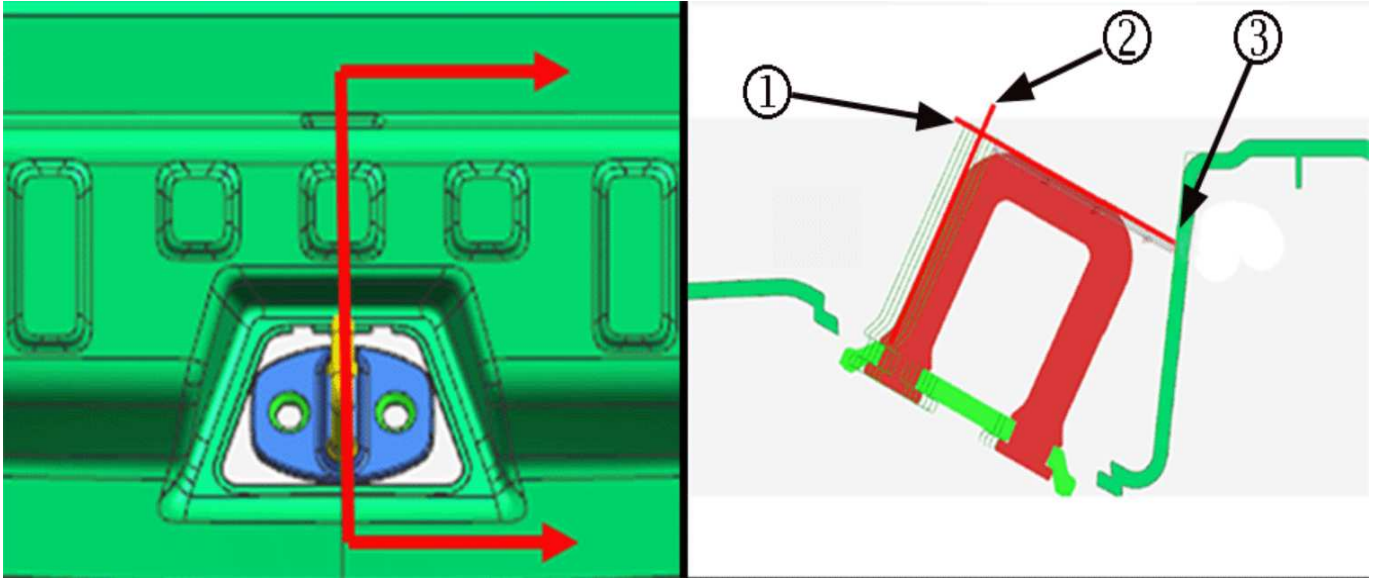
4772397

2. Once the condition is verified, open the liftgate.

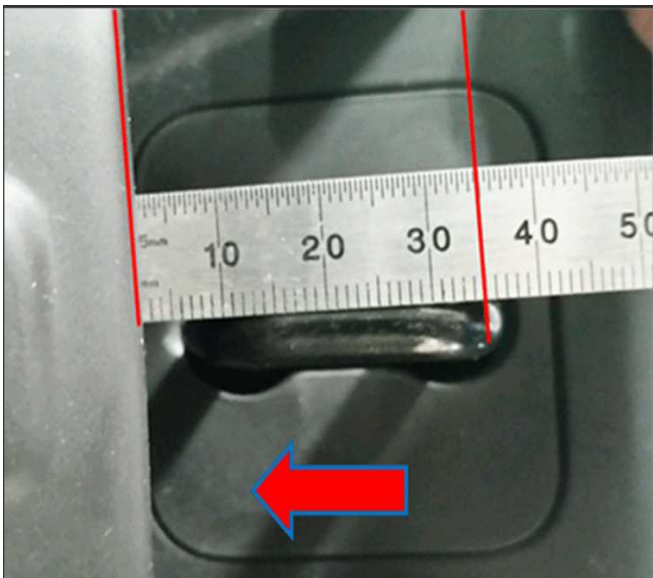
4772398

3. Lay a scale/ruler (1) on top of the liftgate striker and measure the striker position from the rear most edge (2), to the trim panel (3).

- If the striker position measures different than 38 mm (1.50 in), as shown in the graphic example above, continue to the striker adjustment in step # 4.
- If the striker position measurement is 38 mm (1.50 in), the positioning is correct. Jump ahead to the liftgate bumper adjustment in step # 7.

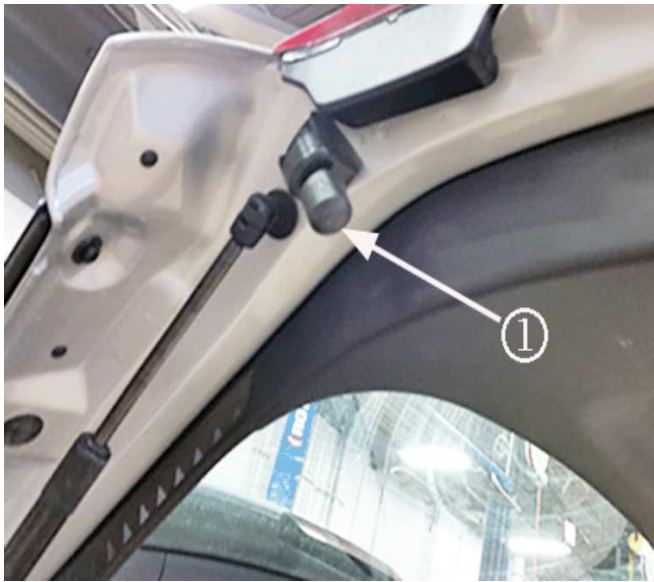
4756821

7. Locate the upper liftgate bumpers (1), one on each side.
