Service Bulletin

Bulletin No.: 22-NA-057

Subject: Fuel Door Does Not Open, Fuel Door Tappet Falls Out of the Hinge

Brand:	Model:	Model Year:		VIN:		Engine:	Transmission:
		from	to	from	to		
Cadillac	Escalade Models	2021	2024	—	—	—	—
	XT6	2020					
Chevrolet	Blazer	2019					
	Suburban	2021					
	Tahoe	2021					
GMC	Yukon Models	2021

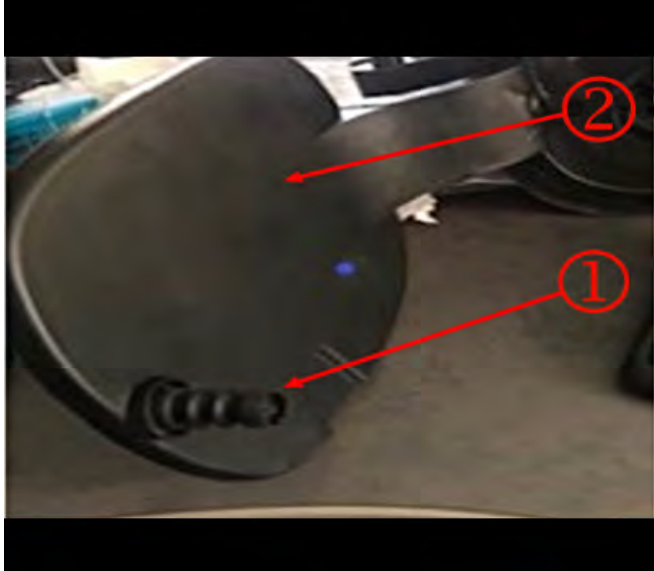
<p>6003725</p>

<p>6014256</p>
<p>This condition may be caused by the tappet, as shown in the picture above (tappet and rubber boot) (1), becomes detached making the tappet loose in the housing hinge (2) misaligning the tappet to the lock actuator or the tappet is no longer retained to the hinge (missing tappet). The misalignment of the tappet to the lock actuator could cause the fuel door to not operate correctly and in some cases damage the lock actuator or lock actuator mount (3), shown in the picture above. A missing tappet boot may also cause the tappet to become detached to the hinge as the boot is part of the secure attachment of the tappet to the hinge.</p>		
<p>Correction</p>	<p>If the tappet or boot is missing, replace the tappet following the procedure below. Note: Replace the fuel door if it is damaged, new fuel door comes with the tappet.</p>

1. Remove the tappet, turn clockwise ¼ turn and discard.
2. Align the new tappet base tabs to the hinge opening and turn counterclockwise ¼ turn, making sure the tappet boot is correctly positioned and

Note: The new tappet should NOT have any movement in any direction.
