## Technical product information

<b>Topic</b>	DTC P0B2500 logged within address 0021 (Battery Energy Control Module 2) - Dynamic ride system warning visible
<b>Market area</b>	Australia E04 Bentley rest Asia and Australia (6E04),China 723 Volkswagen (Anhui) Automotive CO (6723),China 796 VW Import Comp. Ltd (Vico), Beijing (6796),Germany E02 Bentley rest Europe (6E02),Japan E03 Bentley Japan (6E03),Korea, (South) E08 Bentley South Korea (6E08),United Arab Emirates E06 Bentley Middle East and Africa (6E06),United Kingdom E01 Bentley UK (6E01),United States E05 Bentley USA and rest America (6E05)
<b>Brand</b>	Bentley
<b>Transaction No.</b>	2068946/6
<b>Level</b>	EH
<b>Status</b>	Approval
<b>Release date</b>

DTC P0B2500 logged within address 0021 (Battery Energy Control Module 2) - Dynamic ride system warning visible

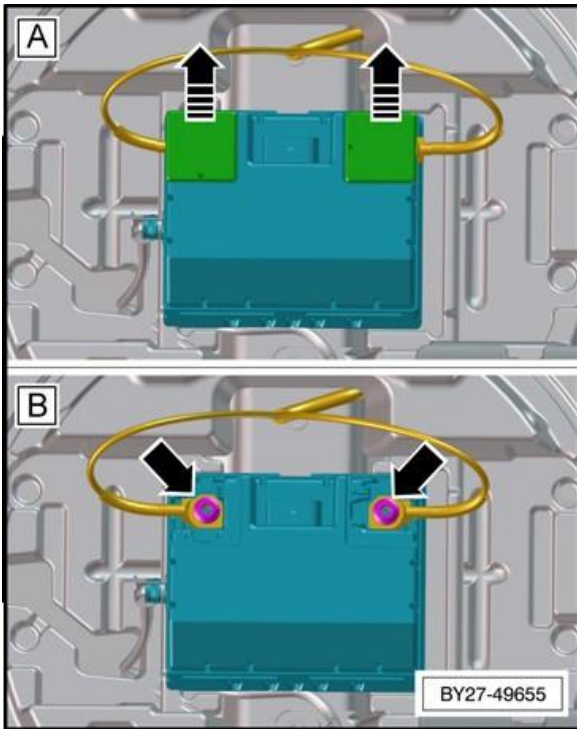
Figure 1

Possible internal fault with the super capacitor

- 1) Referring to Rep.Gr 27 - Deactivate the 48 volt system - Refer to 48 volt system - To activate and deactivate
- 2) Referring to Rep.Gr 27 - Check the security of the super capacitor positive and negative terminals (Figure 1) as follows:
  - Remove the caps (A) from the terminals
  - Check the security of the positive and negative terminals (B) are as described within Rep.Gr 27
  - In the event that one or both terminals are not secure the operative must secure the loose terminal(s) to the correct torque as detailed within Rep.Gr 27 - Super capacitor
