Service Bulletin

Bulletin No.: 23-NA-209

Subject: Oil Can and/or Pop Noise from Roof Area During Car Wash

Brand:	Model:	Model Year:		VIN:		Engine:	Transmission:
		from	to	from	to		
Chevrolet	Colorado	2023	2024	-	-	All	All
GMC	Canyon

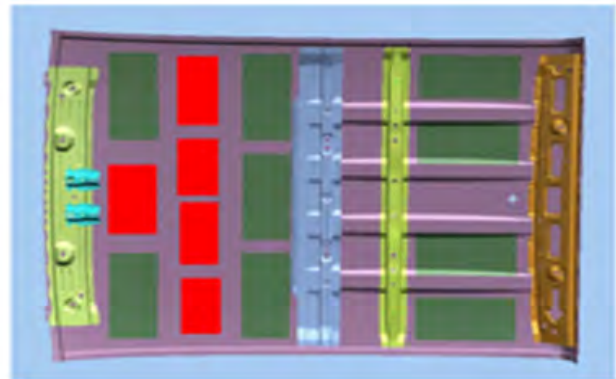
6484170

Involved Region or Country	North America
Additional Options (RPOs)	Excluding all vehicles equipped with Sunroof (RPO -CAC)
Condition	Some customers may comment on a oil canning or popping noise originating from the roof area during or after a automatic car wash.
Cause	The cause of the condition may be force from some air dryers at a automated car wash can cause flex in the roof panel, causing a loud oil canning type sound.
Correction	Repair any damage done during the event and apply stiffening patches to the underside of the roof panel following the procedure listed below.

- Once the headliner is dropped (but not removed) apply the 5 stiffening panels to the underside of the roof panel in the **RED** locations in the illustration above.
- Once the panels are installed, reinstall the headliner. Refer to *Headlining Trim Panel Replacement* in Si.
- Verify the condition is corrected.
