Service Bulletin

Bulletin No.: 19-NA-255

Subject: Wax Coating on Frame Peeling, Metal Shows Corrosion/Rusting

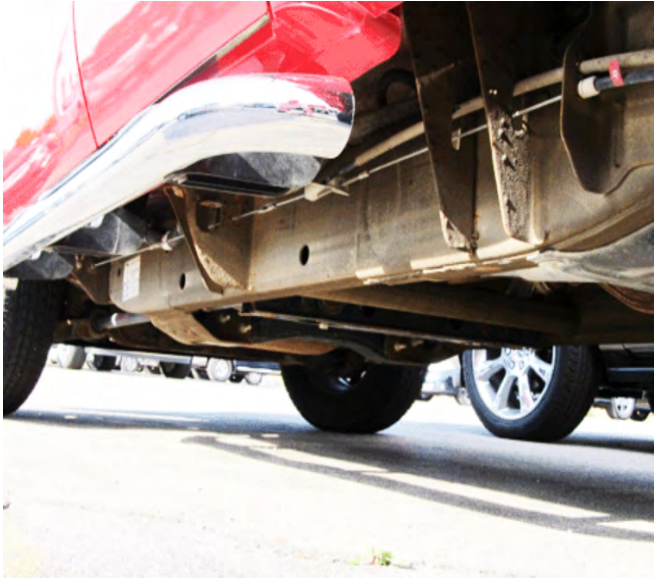
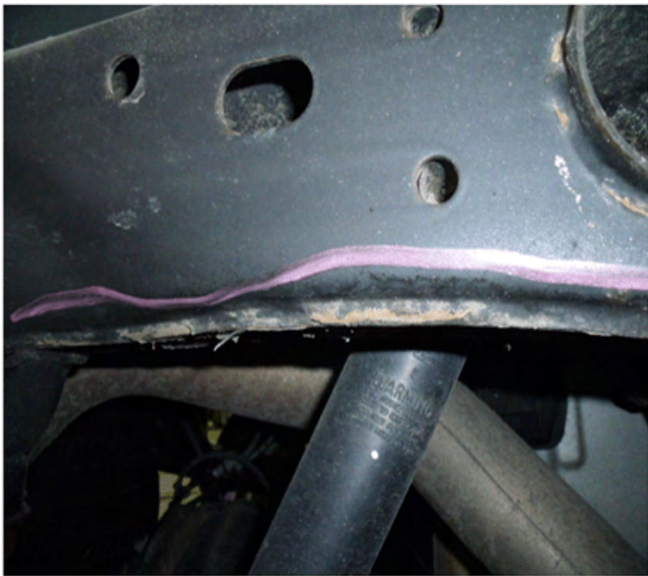
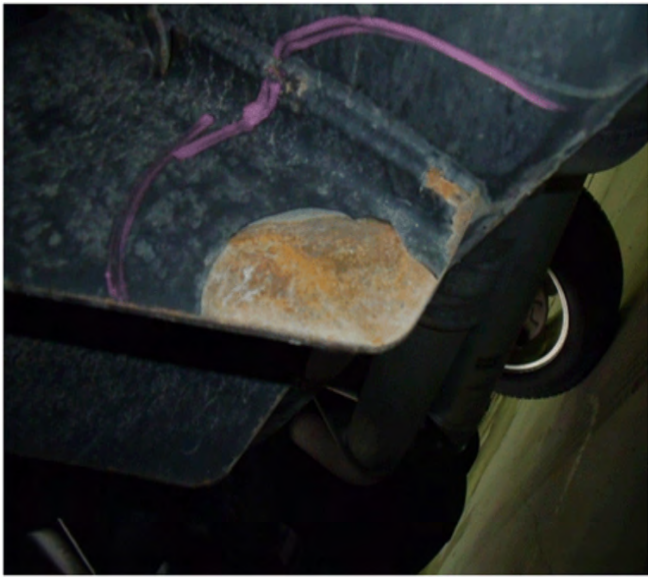
<p>Involved Region or Country</p>	<p>North America, Europe, Middle East, Israel, Palestine, Chile, Columbia, Ecuador, Paraguay, Peru, Uruguay, Japan, S Korea, China, Taiwan, Thailand, Africa and Egypt, Russia, Uzbekistan, S. Africa, Australia and New Zealand.</p>
<p>Condition</p>	<p>Some customers may comment that areas of the frame wax coating are peeling off and rust/corrosion is visible on the metal in these areas. Several examples of this condition are shown in each group of graphics below.</p> <p>Truck Example Photos</p>

<p>Cause</p>	<p>The cause of this condition may be that the frame supplier may not have properly prepped the metal before the wax coating was applied.</p>
<p>Correction</p>	<p>Note: A combination of specialized metal coating products manufactured by Lloyds and Daubert have been found to be the most suitable products to provide corrosion control and protection to address this type of repair. Our recommendation is to prep the metal surface using *Lloyd's Pure Prep™ Metal Surface Preparation P/N 25418, then topcoat with both *Lloyds Kryptonite™ Metal Treatment* - P/N 36500 High Temp Satin Black 455 ml (16 oz), and *Daubert Non-Rust® P/N X-121B One Coat Rust Preventative Coating. It is strongly recommended they be applied according to the manufacturer's procedures.</p> <p>*We believe this source and their products to be reliable. There may be additional manufacturers of such products/materials. General Motors does not endorse, indicate any preference for, or assume any responsibility for the products or material from this firm or for any such items that may be available from other sources.</p> <p>Prep the frame and apply the Lloyds and Daubert coatings following the steps in the Service Procedure below:</p>
