SIB 64 05 24

2024-03-27

INTERIOR HEATING REDUCED IN COLD TEMPERATURES

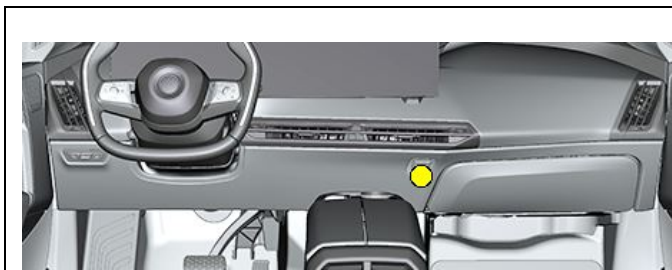
NO: If there is a customer concern for this situation **AND** the I-Level was newer than 22-11-540, only then replace the interior temperature sensor (B857, general location shown).

Follow **Repair Instruction 6411938** "Removing and installing/replacing the temperature sensor for the vehicle interior".
