SIB 46 02 24

SERVICE SOLUTION: R 1300 GS RIDE HEIGHT SENSOR/S
CALIBRATION FAILS

2024-03-28

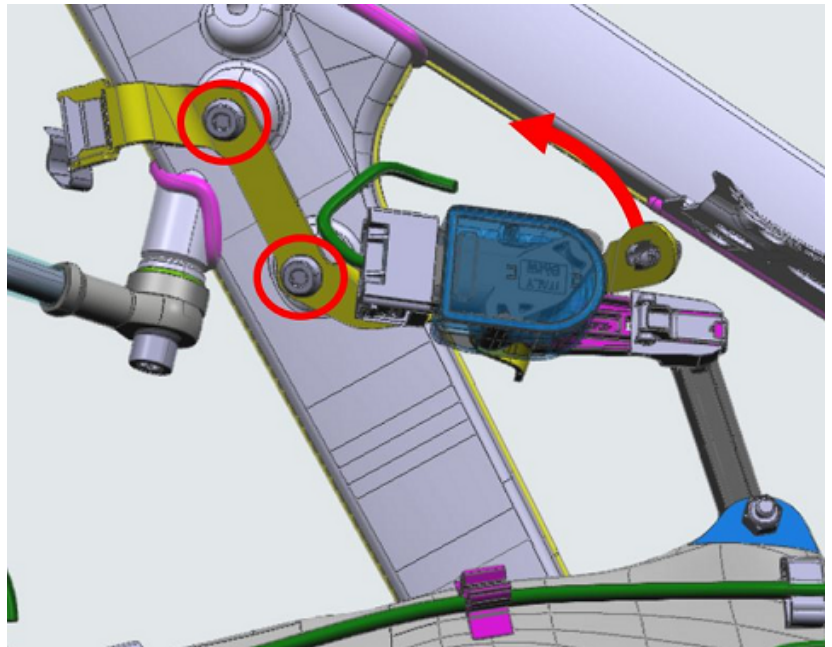
Front ride height sensor:

Calibration of one or both ride height sensors fail due to the ride height sensor/s are not positioned correctly.

- Loosen the fasteners of the holders on the frame.
- Then turn the holder counterclockwise (upwards) within the hole clearance and tighten the fasteners to the required torque.
