**Technical Information**

FROM: Maserati TSO

# Headlight Taillight Condensation

**MODELS:** all Maserati models**SECTION:** 08.30-1 FRONT LIGHTS and 08.31-1 REAR LIGHTS**CUSTOMER CONCERN:** condensation inside headlights and taillights**ANOMALIES:**

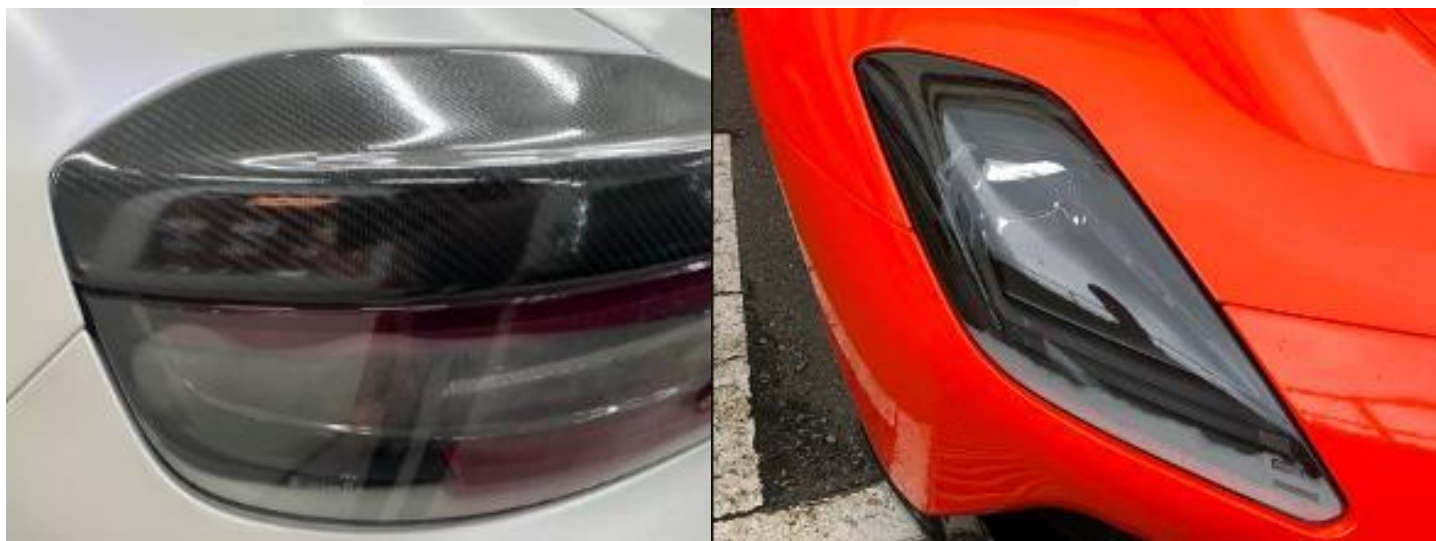
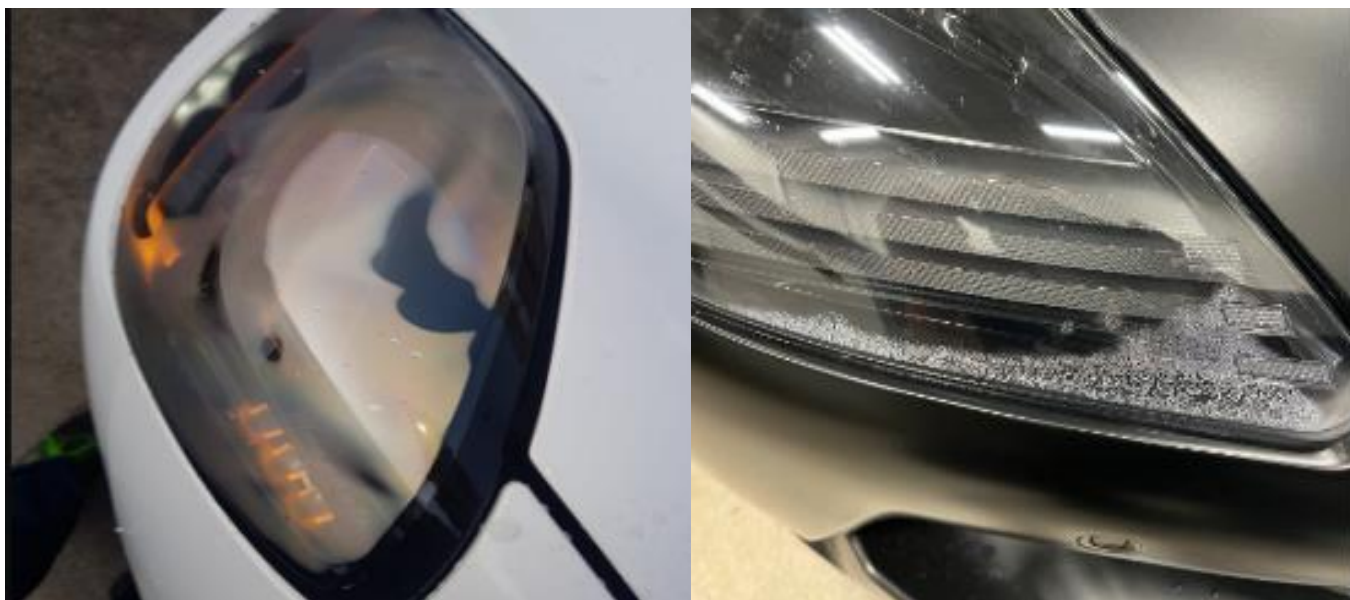
## **A) Condensation during high humid environmental conditions (Normal)**

Condensation is a physical and natural phenomenon of headlights and taillights that can occur during highly humid environmental climate conditions such as heavy rain or thunderstorms, as the external air is humid and there is a difference in temperature between the outside and the inside of the housing unit.

In highly humid conditions, fogging and or the presence of thin mist (no streaks, drip marks, or droplets) may form inside the headlight and taillight units (see the examples below):

Do not replace any components. Instead, inform the customer that it is a natural physical phenomenon that occurs in particular conditions (heavy rain, thunderstorms, car wash, temperature changes) when ambient air is very humid and there is a temperature difference between the inside and outside of the headlight and taillight assembly.

The lighting units are equipped with natural or forced ventilation systems to guarantee the ventilation necessary to disperse any condensation that forms on the coldest parts of the same. To eliminate condensation through the circulation of air inside the component it is therefore necessary to drive the car for a certain time, which can strongly depend on the environmental conditions such as humidity and atmospheric temperature.

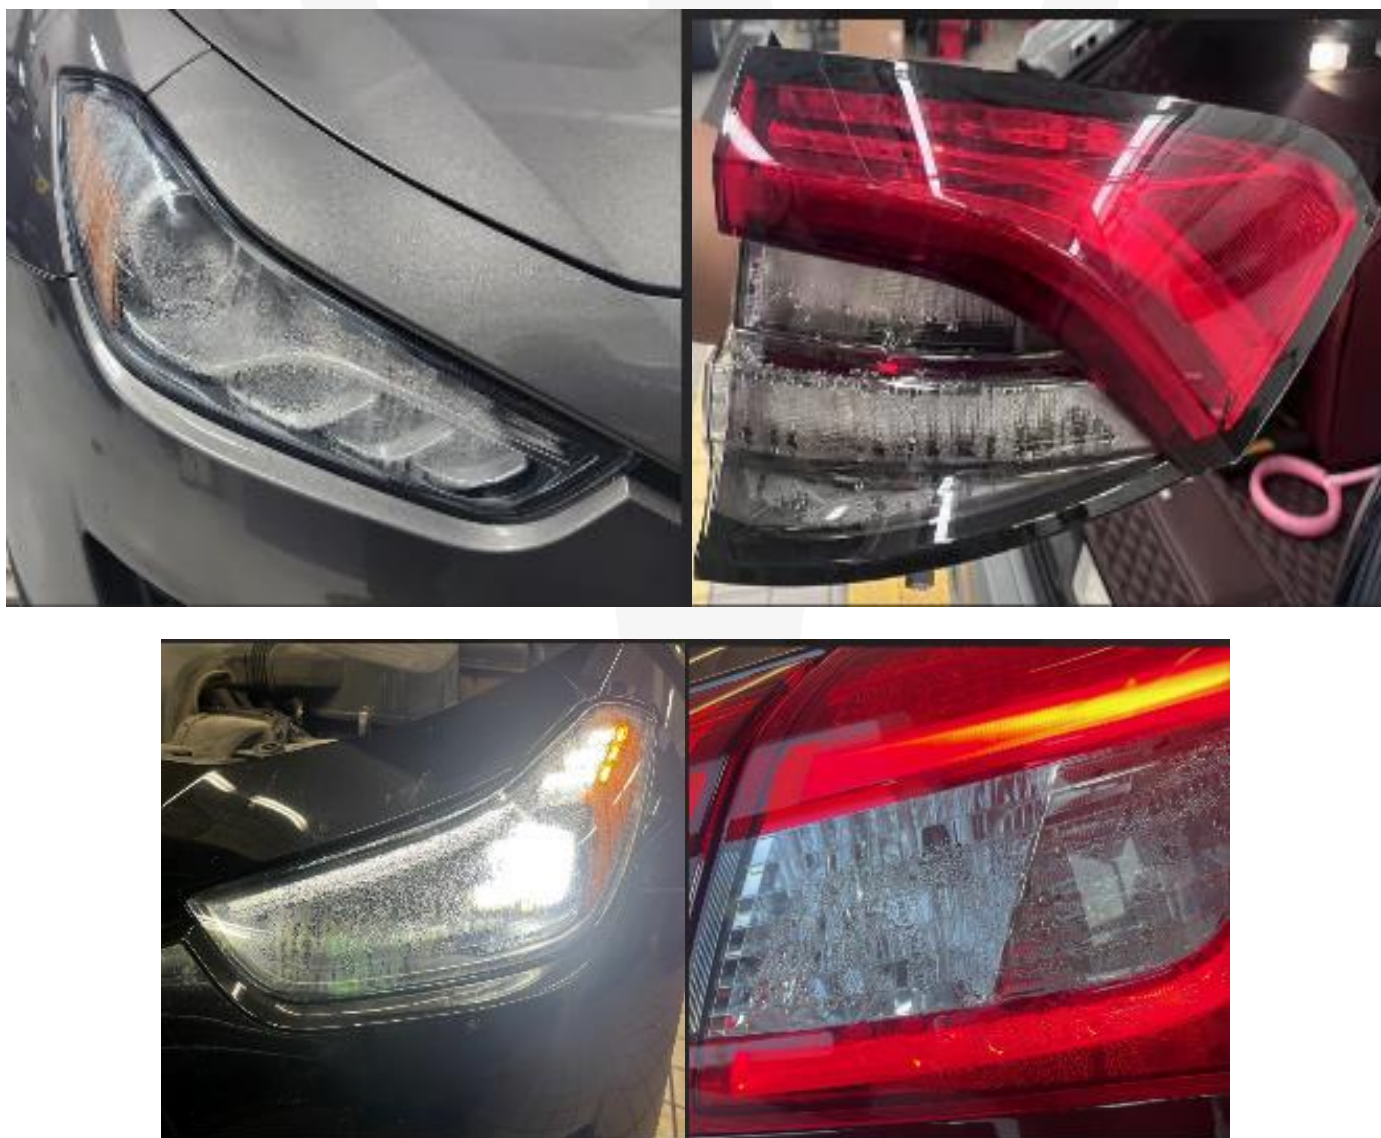
### **B) Condensation due to water infiltration (Abnormal)**

Water infiltration into the lighting units, with drops/streams of water and/or accumulations of water inside the component (Water puddle) (see examples below):

In the event that water infiltrations are found in the headlight and taillight units, for vehicles under warranty, Open BOL for "SUPPORT REQUEST" attach detailed photos/videos of the anomaly and showing any evidence of damage or loss of sealing.

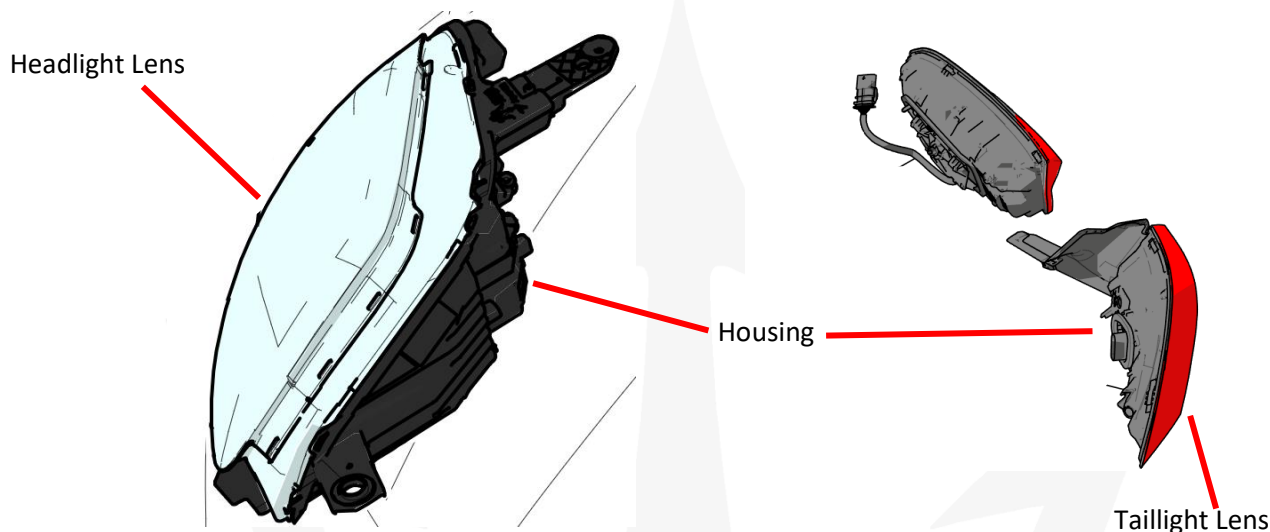
**DIAGNOSIS:**

- Check for any cracks or breakages on the external surface of the lighting unit or the coupling surface between the external lens and the back housing. Water or steam may penetrate through such defects.
- Check for any damage or cracks on the rear part of the housing assembly (inspection caps, connector, housing). Water or steam may penetrate through such defects
