MAS003892 RU 24-04

Rapid Update 691 Granturismo – Engine cooling fan Check

DATE: FEBRUARY 13, 2024

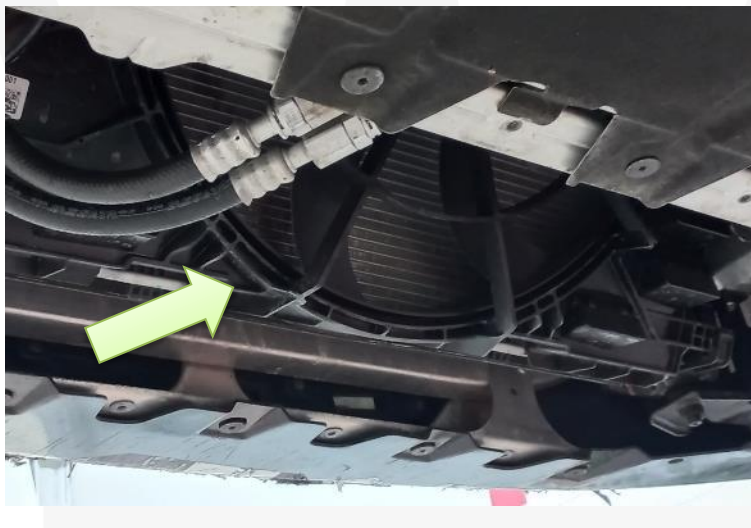
1. Identify the fan and check that it is free to move, manually spin the fan a few turns. Make sure that the movement is fluid and doesn't bind.
2. If the movement is smooth and doesn't bind the fan is **OK**. Proceed with the ACTIVE TEST.
