# Front Seat Cushion Shield Loose/Broken

**Service Category** Vehicle Interior

**Section** Seat

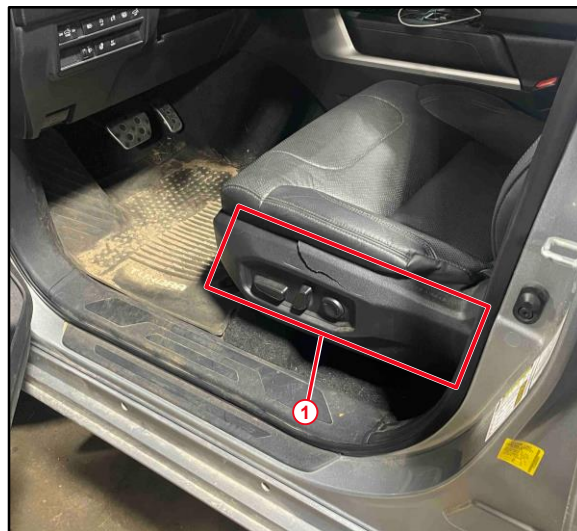
**Figure 1.**

Some 2022 – 2023 model year Tundra and Tundra Hybrid vehicles may exhibit a loose and/or broken front seat cushion shield. This affects 4-way manual (WM) / 8-way power (WP) and 10-WP seats. The condition can occur on the driver and / or front passenger seats. An updated front seat cushion shield is available to improve its durability under typical customer usage conditions. Follow the Repair Procedure in this bulletin to address this condition.

<b>1</b>	<b>Front Seat Cushion Shield</b>
----------	----------------------------------

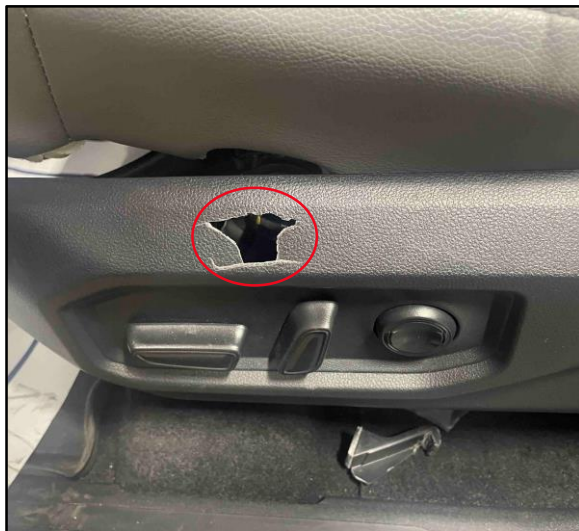
**Figure 2. Loose/Broken Side-cushion Shield (8 WP)**

4. Remove and replace the side power seat cushion shield.  
 Refer to TIS, applicable model and model year Repair Manual:
  - [2022 – 2023](#) Tundra and Tundra Hybrid:  
*Vehicle Interior – Seat – Front Seat Assembly (for Power Seat) – Disassembly*
  - [2022 – 2023](#) Tundra and Tundra Hybrid:  
*Vehicle Interior – Seat – Front Seat Assembly (for Power Seat) – Reassembly*

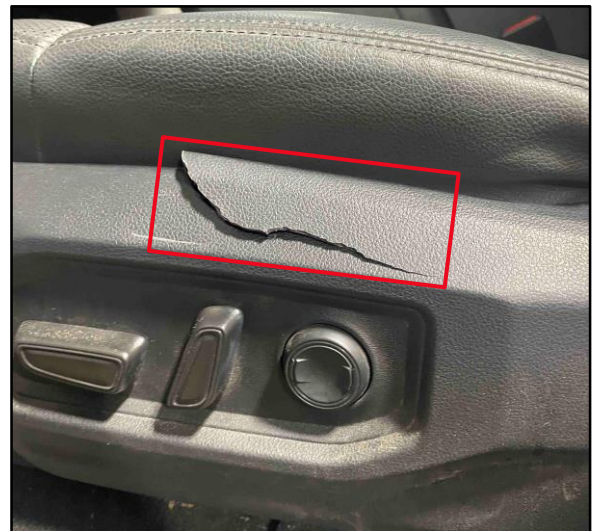
**Figure 3. Broken Side-cushion Shield (8 WP)**

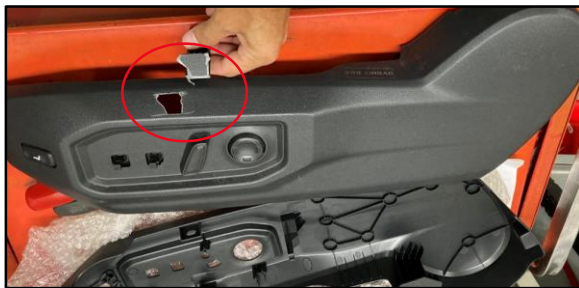
**Figure 4. Broken Side-shield Cushion (10 WP)**

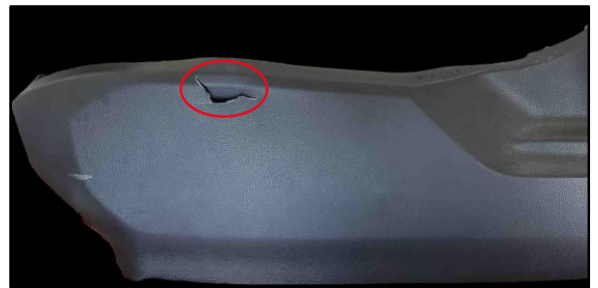
**Figure 5. Broken Side-shield Cushion (4 WM)**

3. Remove and replace the side manual seat cushion shield.  
 Refer to TIS, applicable model and model year Repair Manual:
  - [2022 – 2023](#) Tundra and Tundra Hybrid:  
*Vehicle Interior – Seat – Front Seat Assembly (for Manual Seat) – Disassembly*
  - [2022 – 2023](#) Tundra and Tundra Hybrid:  
*Vehicle Interior – Seat – Front Seat Assembly (for Manual Seat) – Reassembly*
 Go to step 5.
