TECHNICAL INSTRUCTIONS
FOR
CUSTOMER SUPPORT PROGRAM 22TE09
HV FLOOR UNDER WIRE HARNESS AND REAR TRACTION MOTOR CABLE
CORROSION
CERTAIN 2021 – 2022 MODEL YEAR RAV4 PRIME

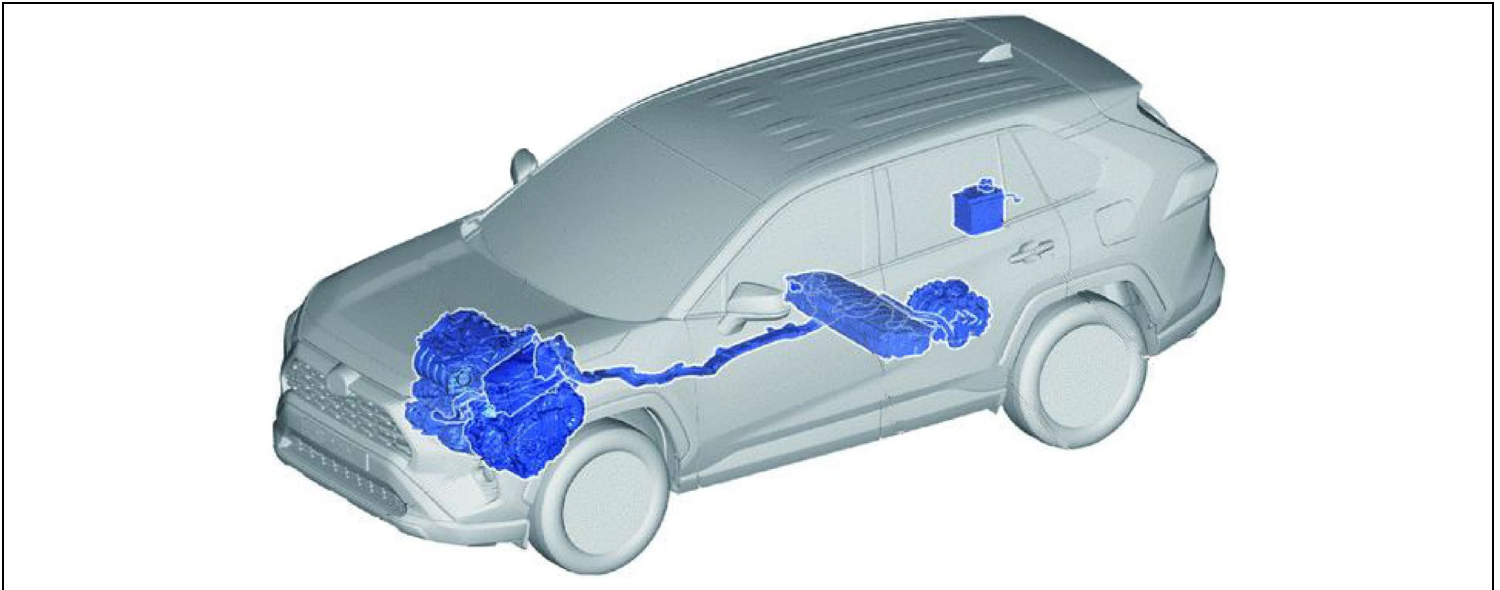
Although the HV Floor Under Wire Harness and Rear Traction Motor Cable is covered by Toyota's New Vehicle Limited Warranty for 3 years or 36,000 miles (whichever comes first), we at Toyota care about the customers' ownership experience. Toyota is providing coverage for repairs related to excessive corrosion to the wire harness connections at the Rear Motor Generator. Excessive corrosion can cause AM Radio Static during certain drive cycles or the vehicle may not start.

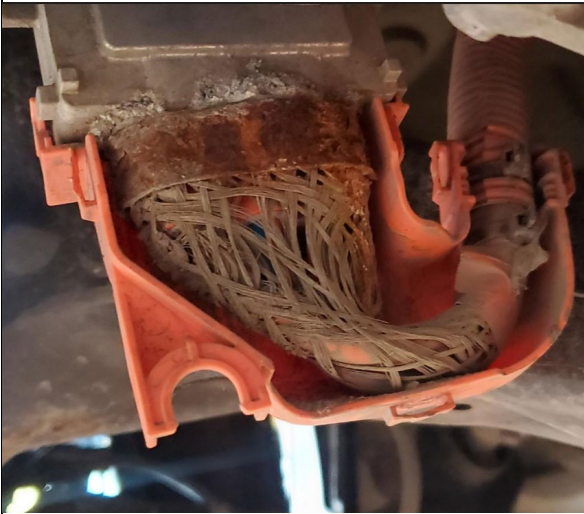
Y6 connector under the vehicle at MGR

- 5) Inspect the Y6 connection for corrosion
f) Disconnect the Y6 connector at the MGR and inspect for corrosion, dirt, or debris.

YES – Continue to Section VI.

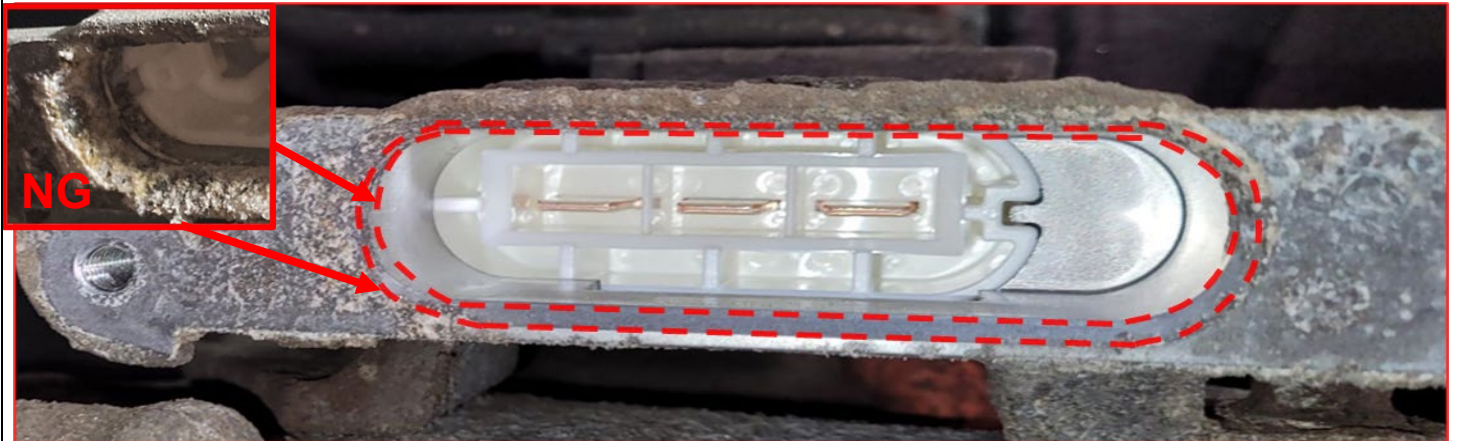
- a) Inspect the chamfer of the MGR connector housing for pitting and corrosion on the sealing surface. Corrosion in this area will cause the seal to leak. Are pitting and corrosion present?

YES – Rear Traction Motor Cable requires replacement continue to Section VI.
