**TECHNICAL INSTRUCTIONS**  
**FOR**  
**CUSTOMER SUPPORT PROGRAM 22TE09**  
**HV FLOOR UNDER WIRE HARNESS AND REAR TRACTION MOTOR CABLE**  
**CORROSION**  
**CERTAIN 2021 – 2022 MODEL YEAR VENZA HYBRID**

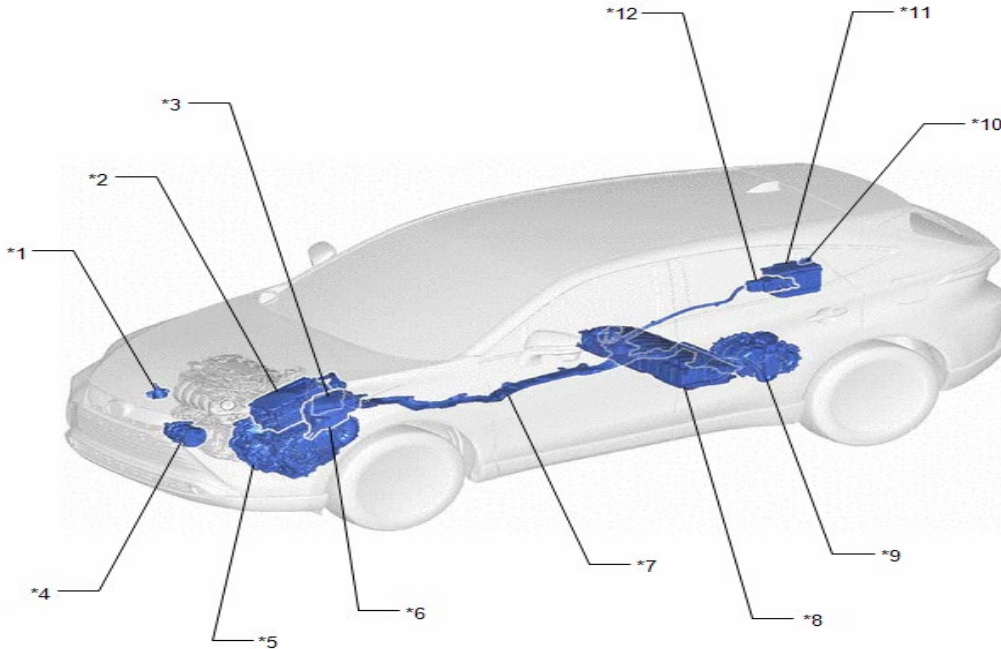
*7	HV FLOOR UNDER WIRE
----	---------------------

Although the HV Floor Under Wire Harness and Rear Traction Motor Cable is covered by Toyota’s New Vehicle Limited Warranty for 3 years or 36,000 miles (whichever comes first), we at Toyota care about the customers’ ownership experience. Toyota is providing coverage for repairs related to excessive corrosion to the wire harness connections at the Rear Motor Generator. Excessive corrosion can cause AM Radio Static during certain drive cycles or the vehicle may not start.

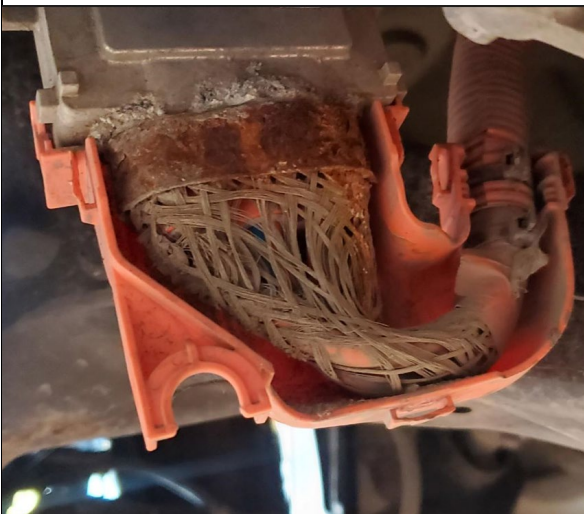
**Y6 connector under the vehicle at MGR**

**5) Inspect the Y6 connection for corrosion**

- f) Disconnect the Y6 connector at the MGR and inspect for corrosion, dirt, or debris.

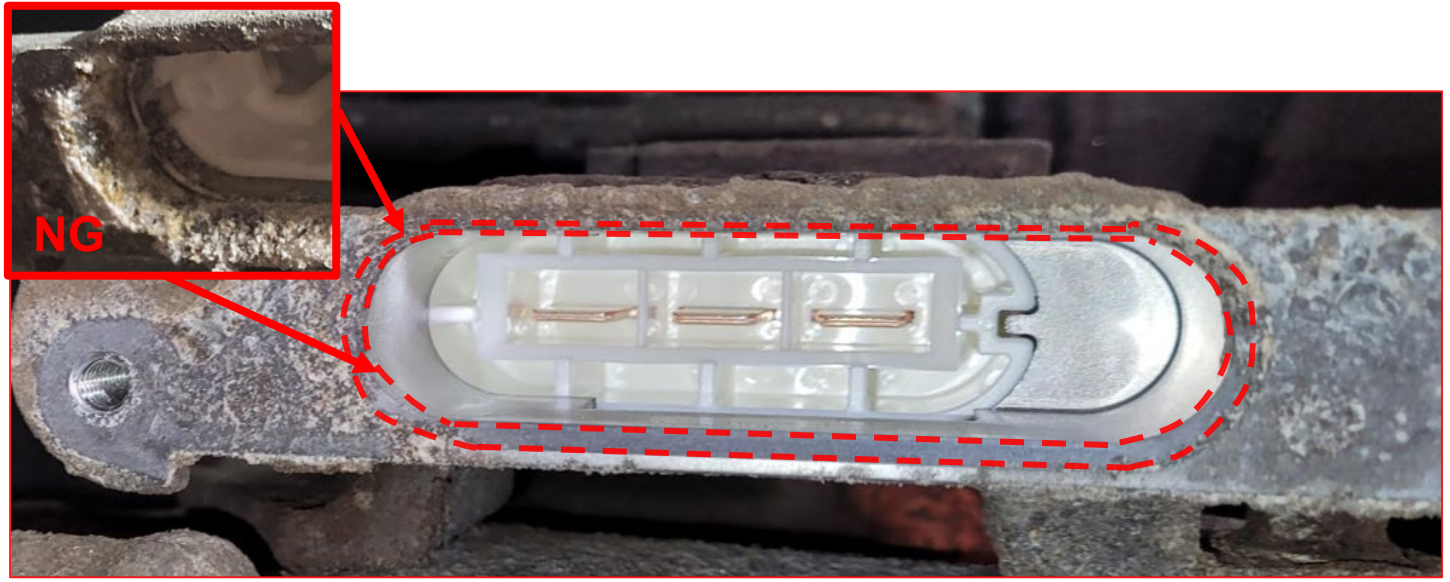
6) Inspect the connector housing of the MGR.

- a) Inspect the chamfer of the MGR connector housing for pitting and corrosion on the sealing surface. Corrosion in this area will cause the seal to leak. Are pitting and corrosion present?

**YES** – Rear Traction Motor Cable requires replacement continue to Section VI.
