SIB 52 10 19

**THIGH SUPPORT UPHOLSTERY DETACHES FROM SEAT**This Service Information Bulletin (Revision 4) replaces SI B52 10 19 **dated February 2022.****What's New:**

E-Series	Model Description
G05	X5 Sports Activity Vehicle
G06	X6 Sports Activity Vehicle
G07	X7 Sports Activity Vehicle

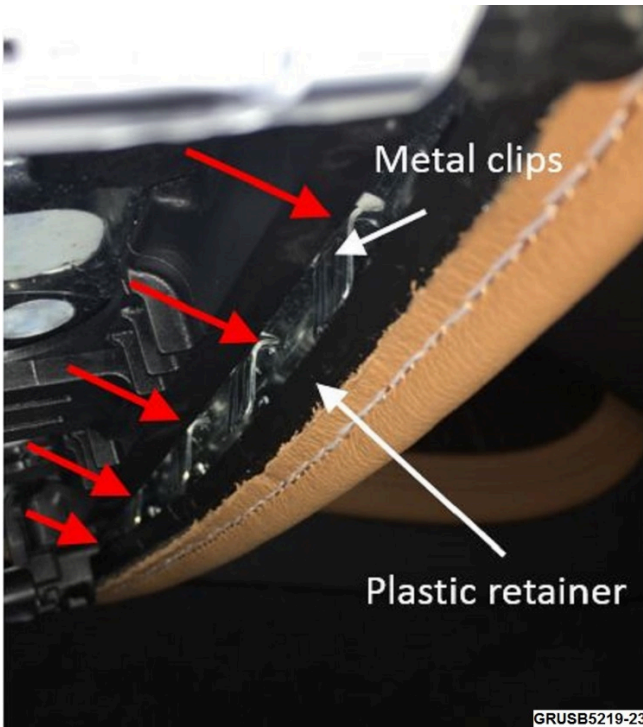
Use a flashlight to inspect underneath the thigh support:

Is the seat leather upholstery damaged?

- YES – Replace the damaged upholstery as needed (refer to ISTA/AIR Group 52 for the applicable repair instructions)
- NO – Check under the seat to see if the upholstery is properly retained under the 5 metal clips

Bend the 5 metal clips as needed to retain the upholstery as shown below in step 6.

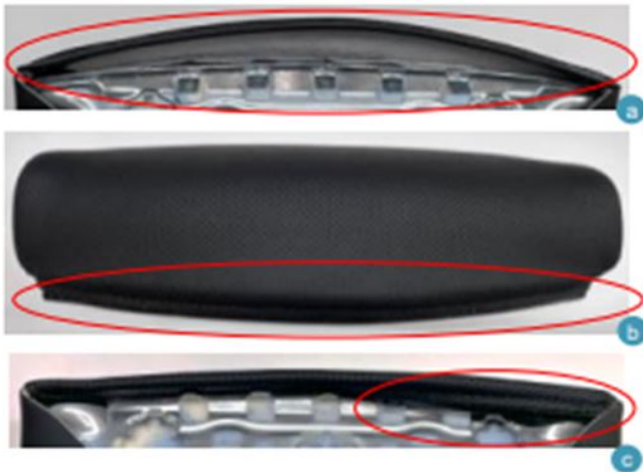
The metal retainer clips on the thigh support are too loose. The clips don't exert enough pressure on the plastic retainer on the edge of the seat leather upholstery, so that the upholstery can separate from the seat's thigh support frame.

2. **Incorrect:** Retainer and trim are not properly installed (red arrows).

- The edge of the leather seat upholstery is sewn onto a plastic retainer strip
- The retainer strip is supposed to be held in place by the firm contact of the 5 metal clips

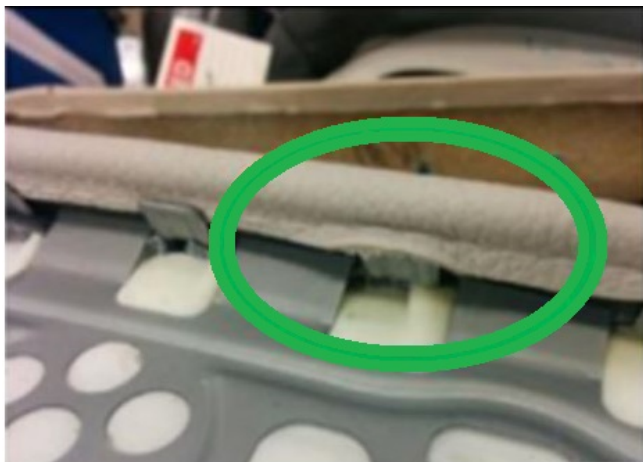
3. **Incorrect:** Retainer and trim not properly attached.

- Leather and retainer not attached to the metal plate.
- Leather and retainer not attached to the metal plate (customer view).
- Leather and retainer not attached completely. Right side is not attached in clips (circled).

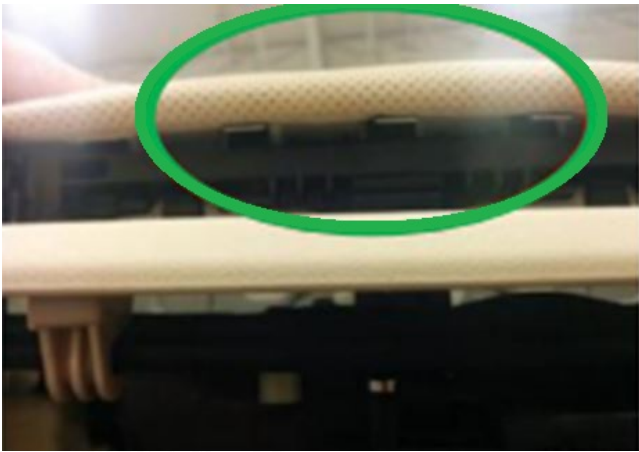
4. **Correct:** Retainer and trim properly attached. Leather may overlap the clip (circled).

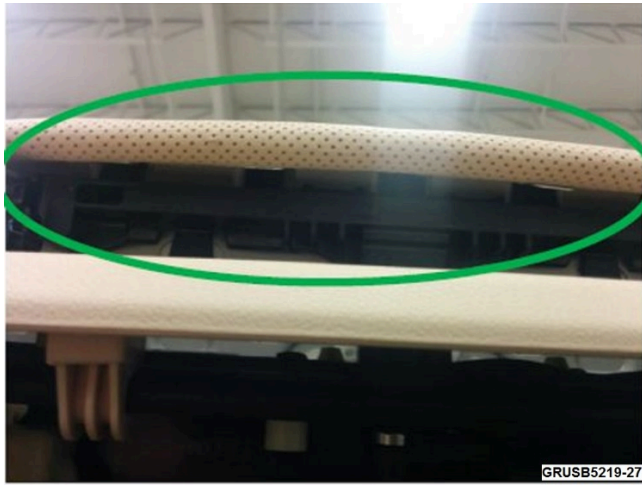
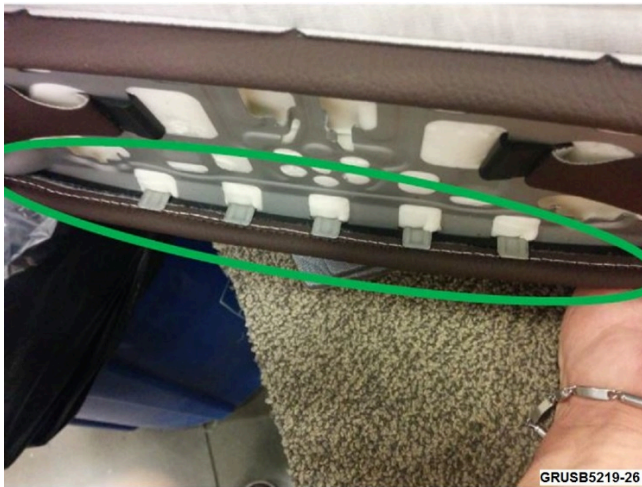
6. **Correct:** Retainer and trim placed correctly inside the metal clips.

- Clips are firmly pressed against the trim
- Slight gaps exist between the trim and metal clips

Note: Bend the 5 metal clips as necessary.
