Field campaign

Topic	Software update to diagnostic address 0006 and 005B - Graphics mismatch in the TSR (SC24/03)
Market area	Australia E04 Bentley rest Asia and Australia (6E04),China 796 VW Import Comp. Ltd (Vico), Beijing (6796),United States E05 Bentley USA and rest America (6E05)
Brand	Bentley
Transaction No.	2073166/1
Campaign number	EC95
Note	
Type	
US code

Bentayga extended wheel base

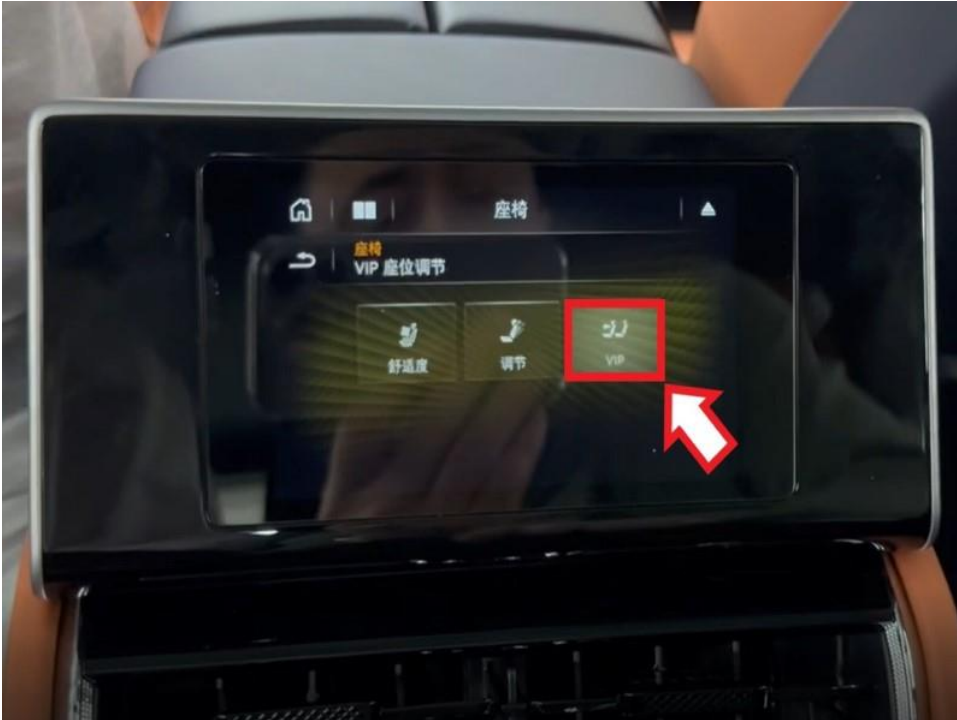
Figure 1

When the VIP seat adjust function (Figure 1) is selected within the Touch Screen Remote (TSR) the requested / actual seat movements are different to those selected / shown on the screen

Hint: The issue relates to a graphics mismatch between the TSR and passenger seat functionality

A software update is available for diagnostic address 0006 - Front passenger seat control unit and the rear passenger seat control unit 005B

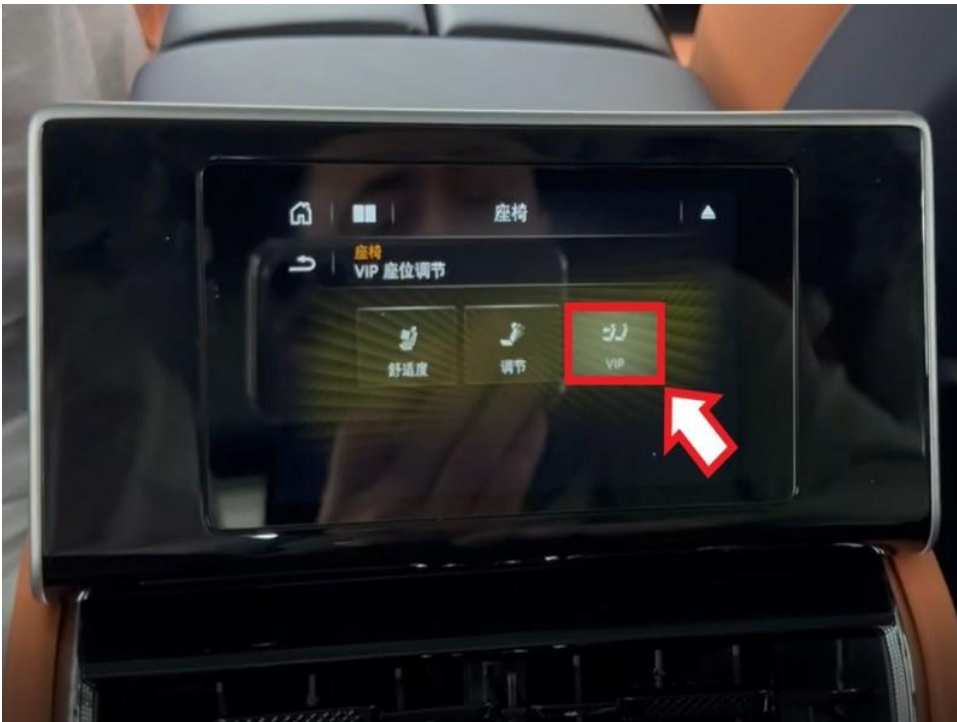
Figure 1

When the VIP seat adjust function (Figure 1) is selected within the Touch Screen Remote (TSR) the requested / actual seat movements are different to those selected / shown on the screen

Hint: The issue relates to a graphics mismatch between the TSR and passenger seat functionality

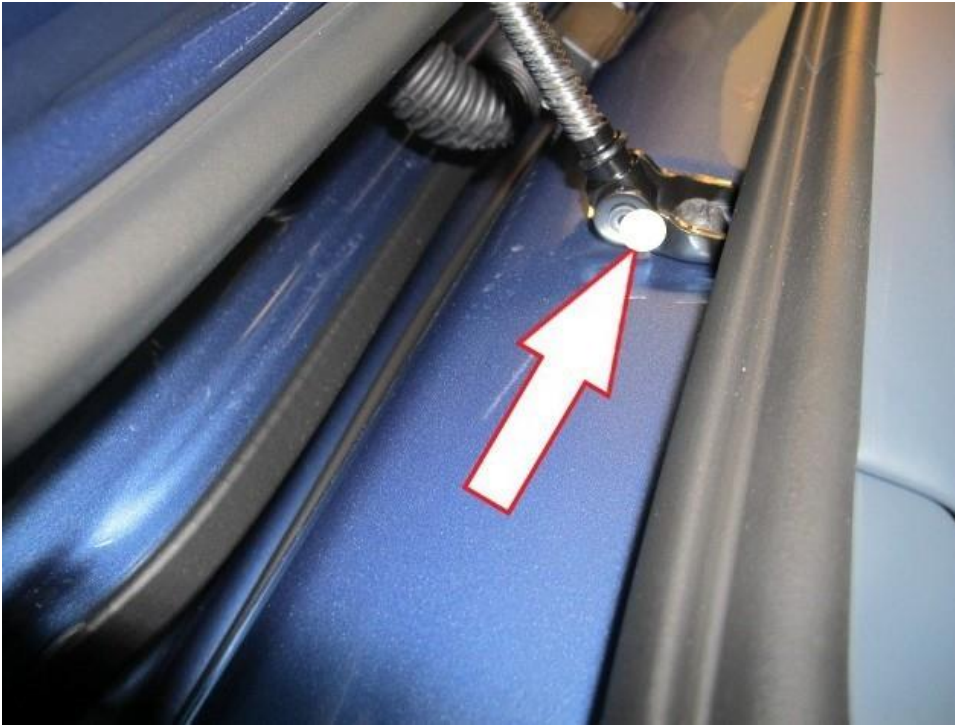
Figure 6

White paint completion mark on the underside of the left hand rear door arrestor bracket (Figure 6)

- 9) Apply a white paint completion mark on the underside of the left hand rear door arrestor bracket (Figure 6)
