**SUBJECT: SERVICE ACTION: OBC REPLACEMENT (SA307)**

GROUP <b>ELE</b>	MODEL <b>2016MY Soul EV (PS EV)</b>
	NUMBER <b>138</b>	DATE <b>September 2017</b>

**TECHNICAL SERVICE BULLETIN**

**ELE138/SA307**

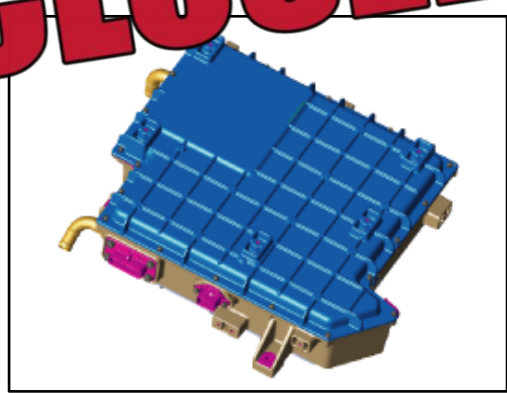
This bulletin provides the procedure to replace the On-Board Charger (OBC) on some 2016MY Soul EV (PS EV) vehicles, produced from January 16, 2015, with the OBC that was installed on or after January 16, 2015, which may exhibit a malfunction indicator light (MIL) or Diagnostic Trouble Code (DTC) P1CF5 or P1CF6 due to a battery charge delay with the OBC. This issue is not related to the OBC that was installed on or after January 16, 2015. Related DTCs are P1CF5 and P1CF6. Before performing this procedure, verify that the vehicle is included in the list of affected VINs.

DTC	Description
P1CF5	MIL Check
P1CF6	MIL Check
