GROUP ELE	MODEL 2017MY Sorento (UMa) Optima (JFa)
NUMBER 131 (Rev 1, 7/21/2017)	DATE April 2017

TECHNICAL SERVICE BULLETIN

SUBJECT: SERVICE ACTION: VOLTAGE REGULATOR PERFORMANCE ENHANCEMENT (SA278)

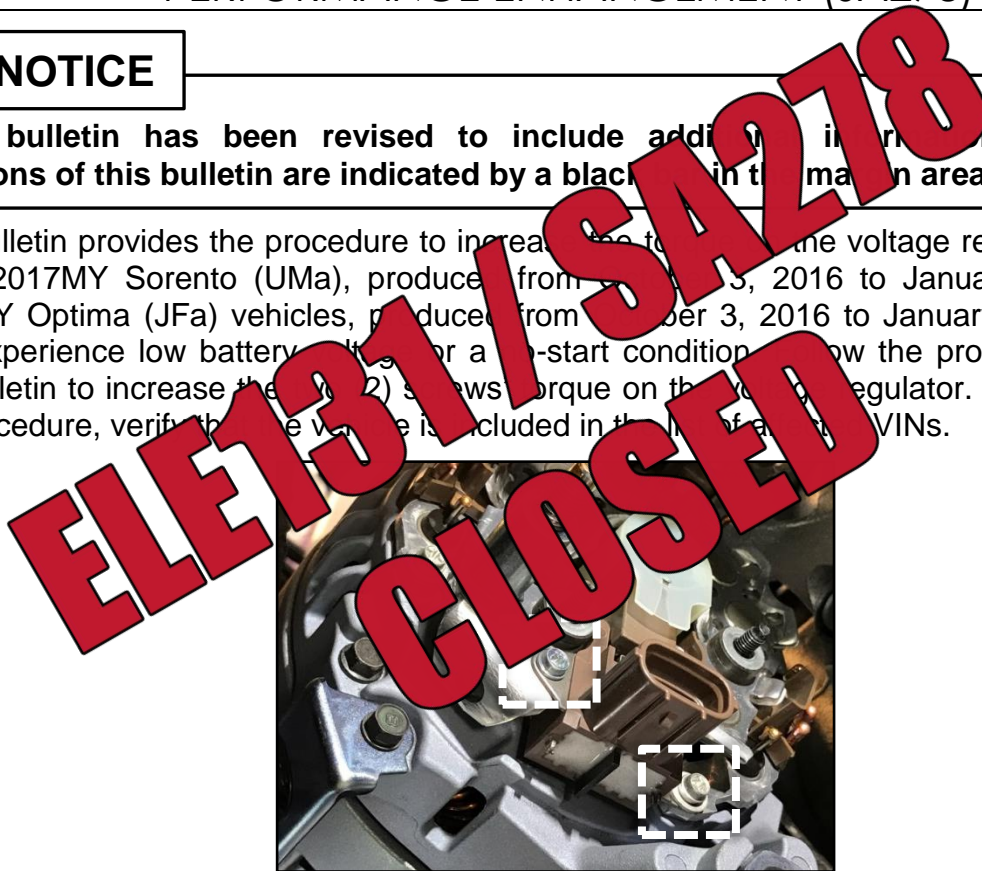
Voltage Regulator Screws

This bulletin provides the procedure to increase the torque on the voltage regulator screws on some 2017MY Sorento (UMa), produced from December 3, 2016 to January 24, 2017, and 2017MY Optima (JFa) vehicles, produced from November 3, 2016 to January 26, 2017, which may experience low battery voltage for a no-start condition. Follow the procedure outlined in this bulletin to increase the (N2) screws torque on the voltage regulator. Before conducting the procedure, verify that the vehicle is included in the list of affected VINs.
