## Turbocharger Mounting Hardware Replacement

**Section** Function Group 255

Mack trucks has determined that certain AN, GR, PI, and TE model trucks built with a MP8 engine could experience a reduced clamping load on the turbocharger mounting hardware causing the hardware to become loose. On affected vehicles follow the instructions below to remove the turbocharger and replace the mounting hardware and mounting gasket with new parts.

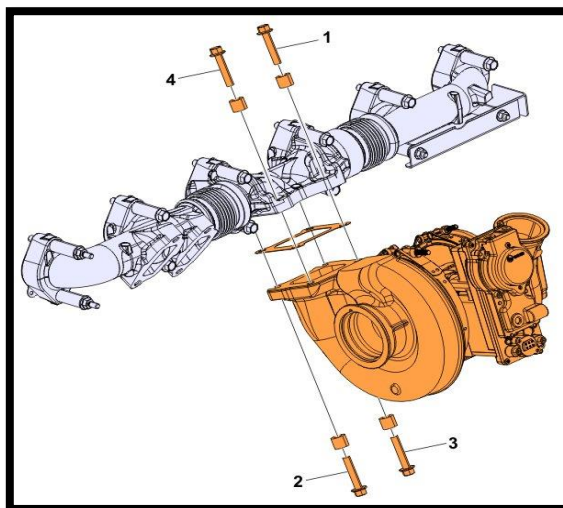
Turbocharger Mounting Hardware must be torqued following the sequence shown below.

| Turbocharger, nut | 1. | <b>Tightening sequence: 1-4</b> |
| | | 20 ±4 Nm (15 ±3 lb <sub>r</sub> ·ft) |
| | 2. | <b>Tightening sequence: 1-4</b> |
| | | 48 ±8 Nm (35 ±6 lb <sub>r</sub> ·ft) |
