Drivers Information Display (DID) Inoperative After Cluster Replacement And Programming

Published Date March 2024

Mack AN,GR,CHU,CXU,PI and Volvo VNR,VNR,VNX,VHU,VHD Model Year 2021 to Current

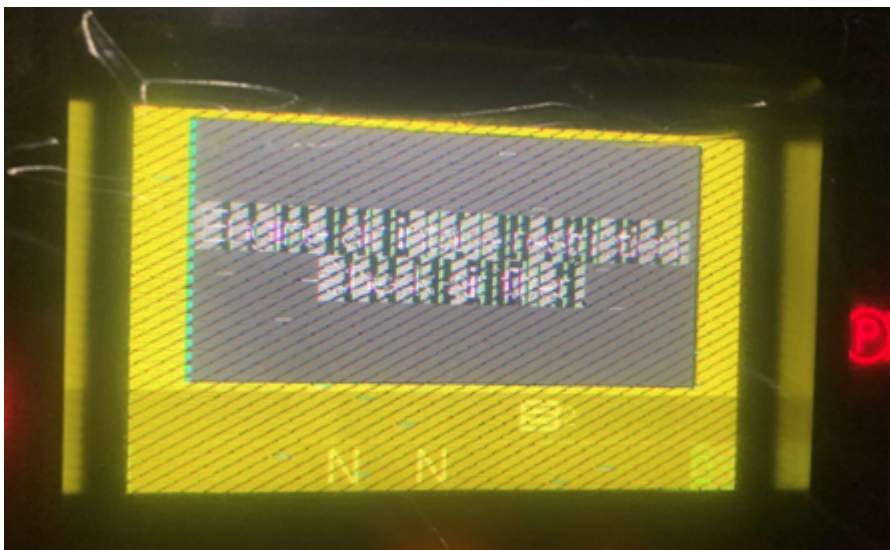
After cluster replacement and programming, the Driver Information Display (DID) may not function as designed. See Image below.

If that occurs, follow these steps:

1. Disconnect the low voltage batteries for 10 minutes.
2. Reconnect the low voltage batteries.

The full power cycle should fix the issue.

If the issue persists, please contact Tech Support.
