## Volvo Chassis - Omnitrac's Electronic Log Devices (ELD) GPS Signal Interference

Published 27 March 2024

Volvo VN models, Model year 2024

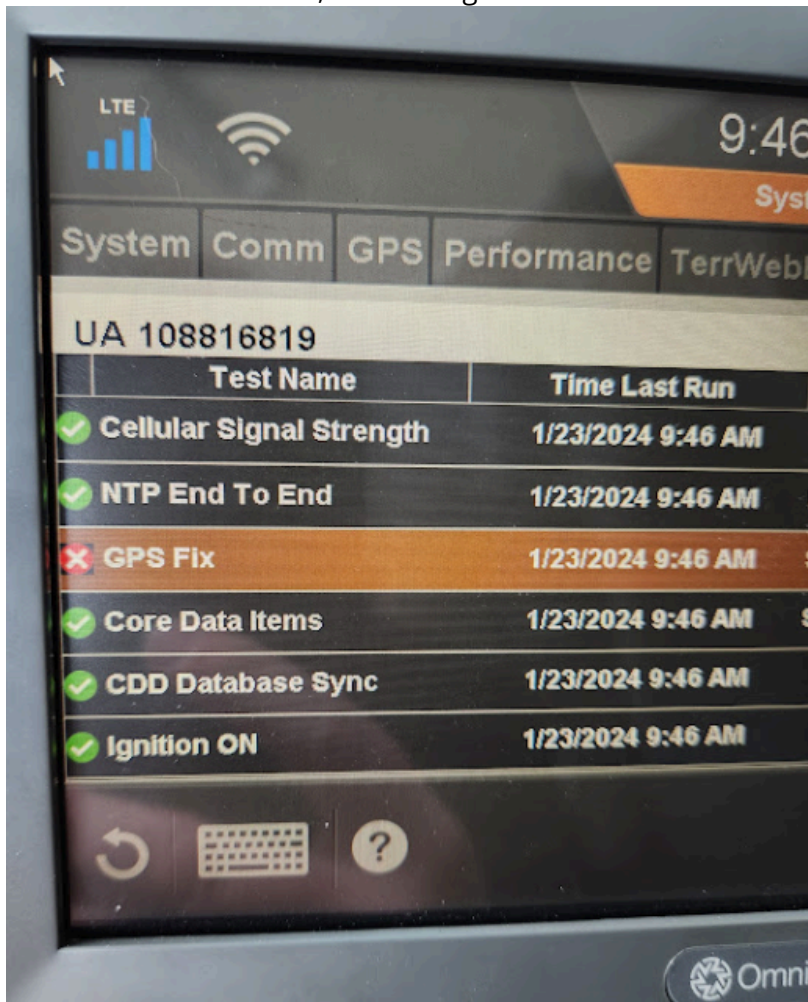
The Omnitrac's ELD may have trouble linking up with the GPS signal. Replacing the Safety Direct Processor (SDP), (FLC), Omnitrac's ELD unit, and overhead harness have had no positive effects. When both Bendix components mentioned are in the vehicle alongside the Omnitrac's ELD, the GPS signal will not connect. However, if the SDP is disconnected, the GPS signal connects without issues.

Replace the existing Safety Direct Processor (SDP) (part number 23960675) with the latest version (part number 24403980). Once the repair has been made verify the GPS signal is present.
