April 2024
SF682AB

Subject: AB12 and Crash Sensors

Models Affected: Specific model years 2023-2024 Freightliner eCascadia vehicles manufactured January 19, 2022, through May 30, 2023.

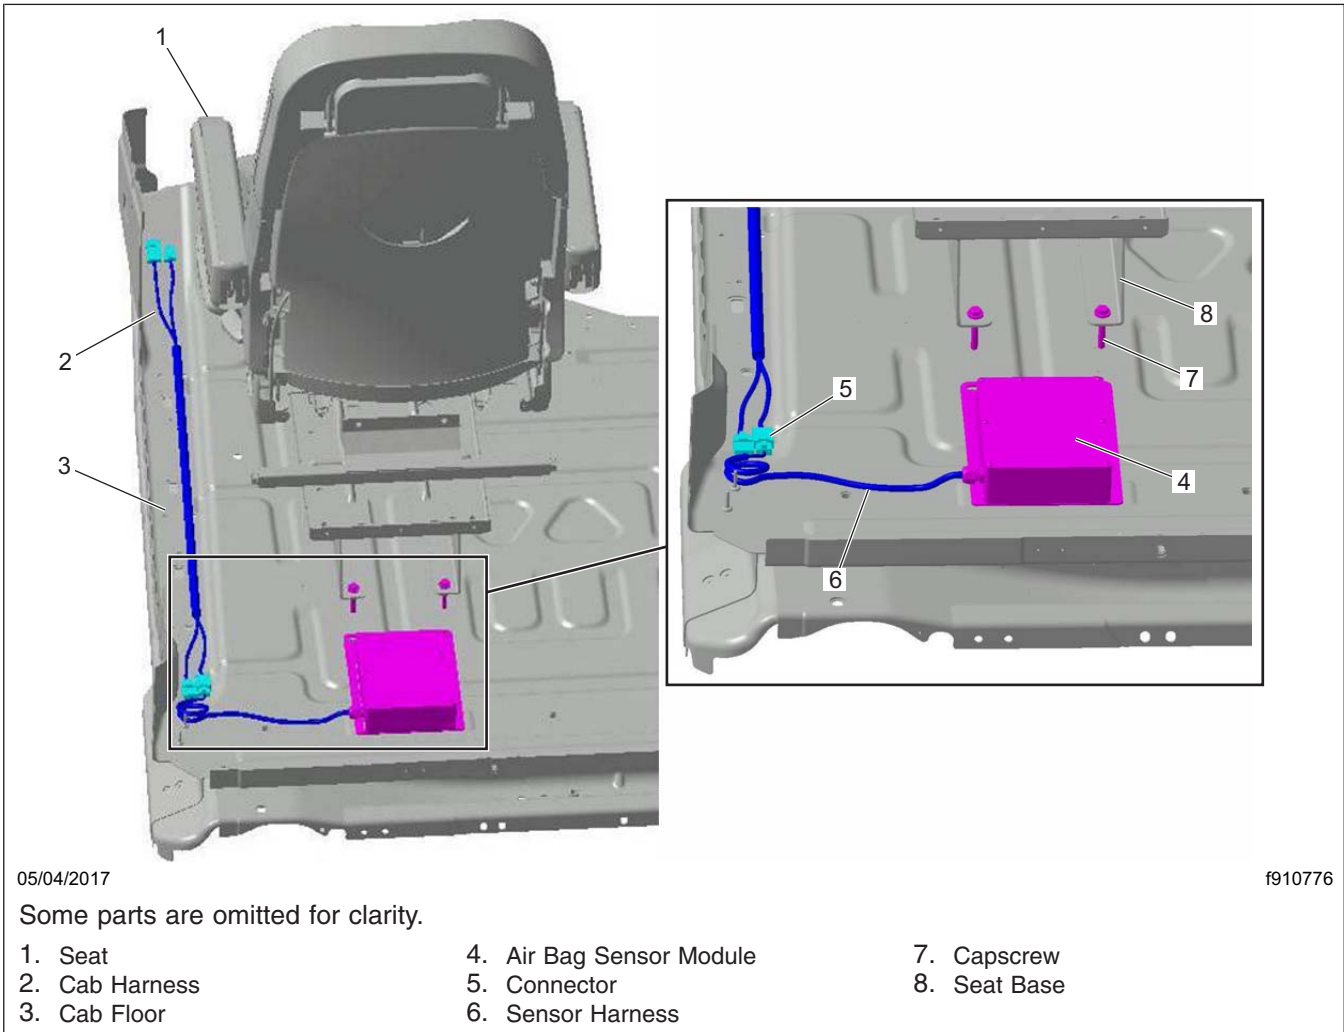
Fig. 3, Air Bag Sensor Removal

Vehicles were built with numerous protections against crash-related damages or high voltage hazards. Early production units were installed with a prior version of AB12 modules and with forward crash sensors not engaged. These will be replaced by upgraded modules with crash sensors engaged. Additionally, optional passenger protection airbag functionality will be enabled on certain vehicles.

14. Remove the capscrews from the air bag sensor, and remove the seat bracket. See [Fig. 3](#).
15. Remove the air bag sensor.

16. Install the new air bag sensor, and route the low-voltage cable.
17. Install the seat bracket and the air bag sensor mounting fasteners. Tighten the fasteners 12 lbf-ft (16 N·m).
18. Connect the low-voltage harness to the air bag sensor.
19. Install the sill cover, and put the weather stripping back in place.
20. Position the seat in place, and install the seat mounting fasteners. Tighten the fasteners 12 lbf-ft (16 N·m).
21. Install the seat belt mounting fasteners, and tighten 41 lbf-ft (56 N·m).

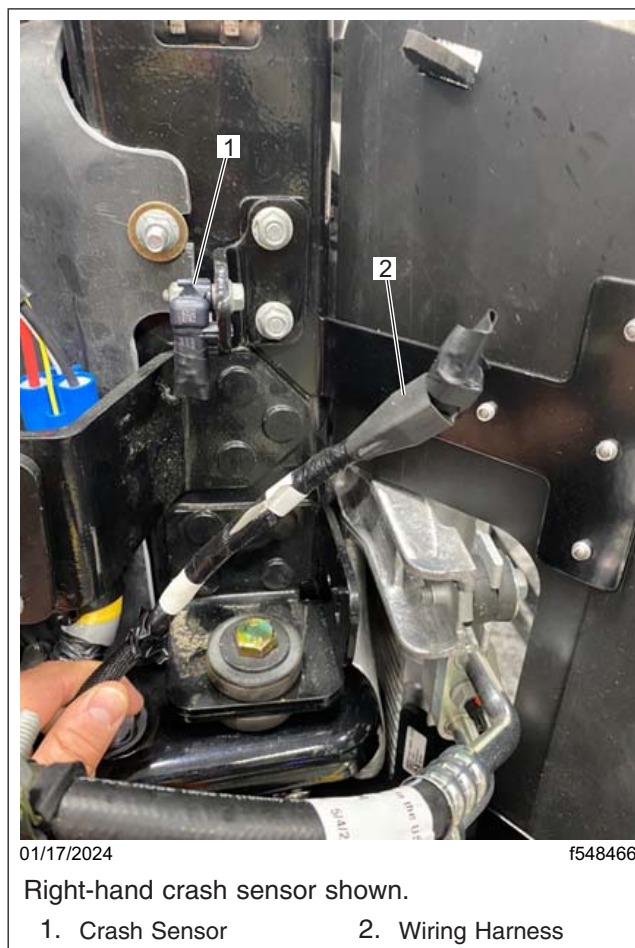
Fig. 4, Radiator-Mounted Crash Sensor

IMPORTANT: Check the radiator-mounted crash sensor connectors for any sign of dirt/corrosion. Clean or repair, as required. If the front crash sensors are damaged or corroded, replace with:

IMPORTANT: Check the radiator-mounted crash sensor connectors for any signs of dirt/corrosion. Clean or repair, as required.

- A66-30389-000 – Left-hand front sensor assembly
- A66-30389-001 – Right-hand front sensor assembly

24. Connect the electrical connectors to the radiator-mounted crash sensors. See **Fig. 4**.
