SS 3142-FTL J1939 CAN issues for vehicles equipped w/ Bendix Side Radar w/ expanded field of view

J1939 500K Problem Identification

Procedure for Unplugging the Bendix Side Radar as Containment

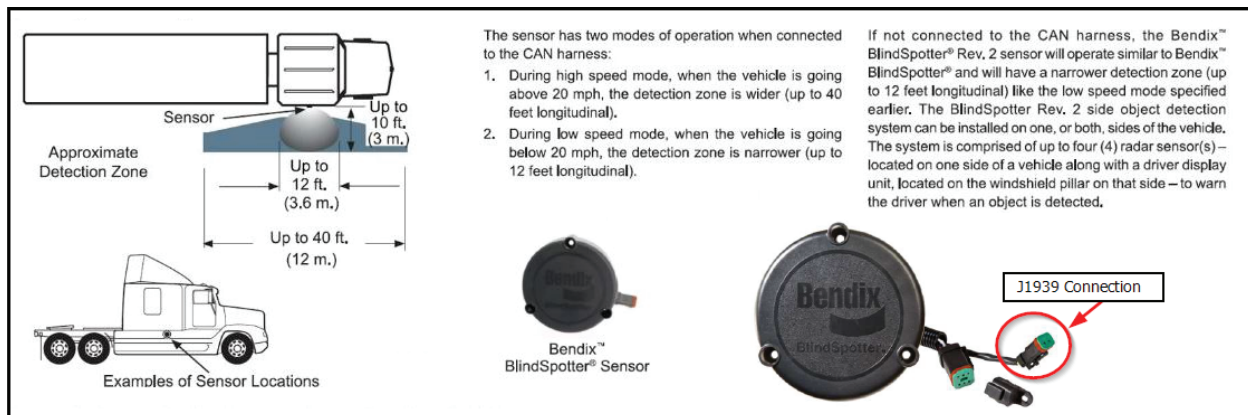
The Bendix Side radar revision 2 uses J1939 to monitor vehicle speed. The containment would include unplugging only the 2-pin J1939 connection to the side radar. Unplugging of the J1939 allows the Bendix side radar to function like the earlier version. The only function difference with the J1939 unplugged relates to vehicle speed. With the J1939 unplugged, vehicle speed above 20 MPH, will not expand the detection zone to up to 40 feet, but rather maintain the roughly 12-foot detection zone as pictured in the Figure 1 below.
