# Adjusting the Coolant Pipe Position

## TSB-20-089 FTL

► eCascadia

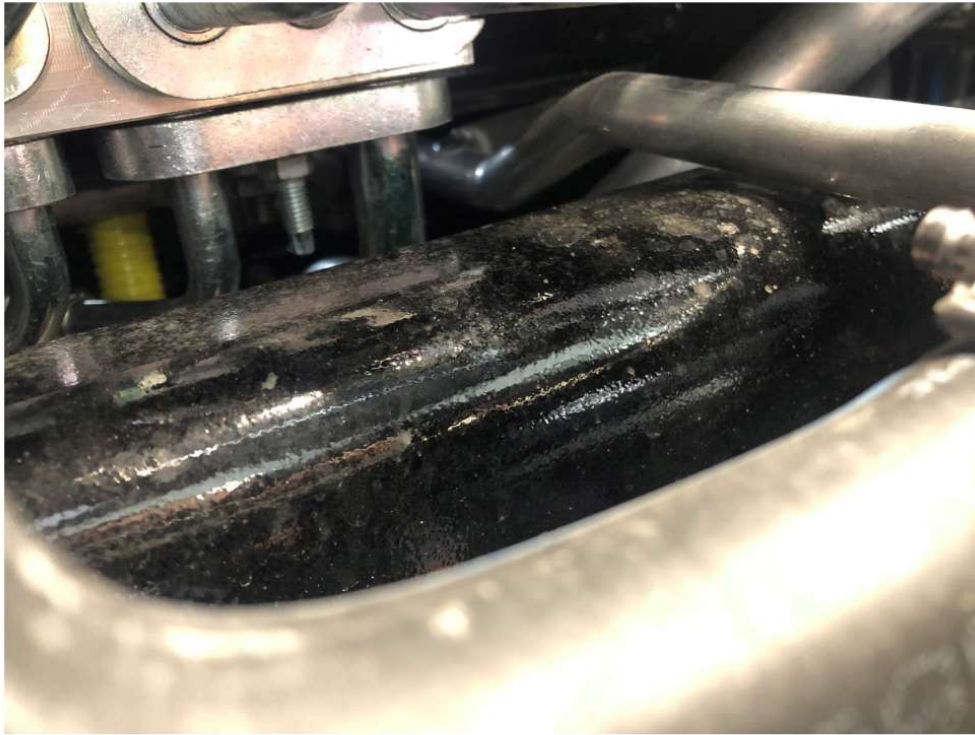
Fig. 1, Checking the Clearance between the Frame Rail and Coolant Pipe

Insufficient coolant pipe to frame rail clearance on eCascadia vehicles can rub the coolant pipe, which may result in excessive chaffing. Use the following directions to adjust the coolant pipe position.

4.  Check the clearance between the coolant pipe and the frame rail. See figure [1](#).  
Is the clearance 3/4-inch (19 mm) or more?

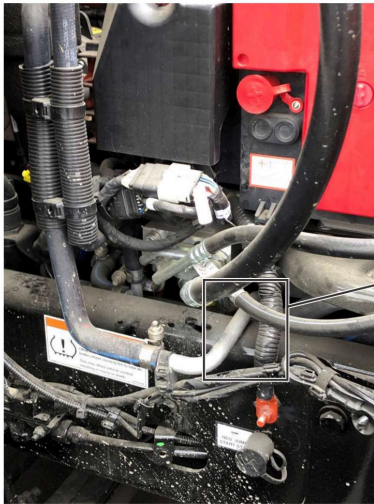
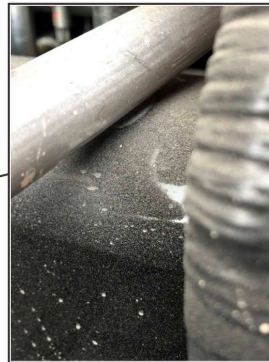
Fig. 2, Before Adjustment

**NO** → Go to step 5. See figure [2](#).

5.  Loosen the bolt and lift up the coolant pipe. See figure [3](#).

6.  Tighten the bolt 11 lb·ft (15 N·m). See figure [4](#).
