# Fixing eAxle Oil Seepage at the Shift to Neutral Tool/Plug Location

## TSB-35-040-FTL

- ▶ eM2
- ▶ eCascadia

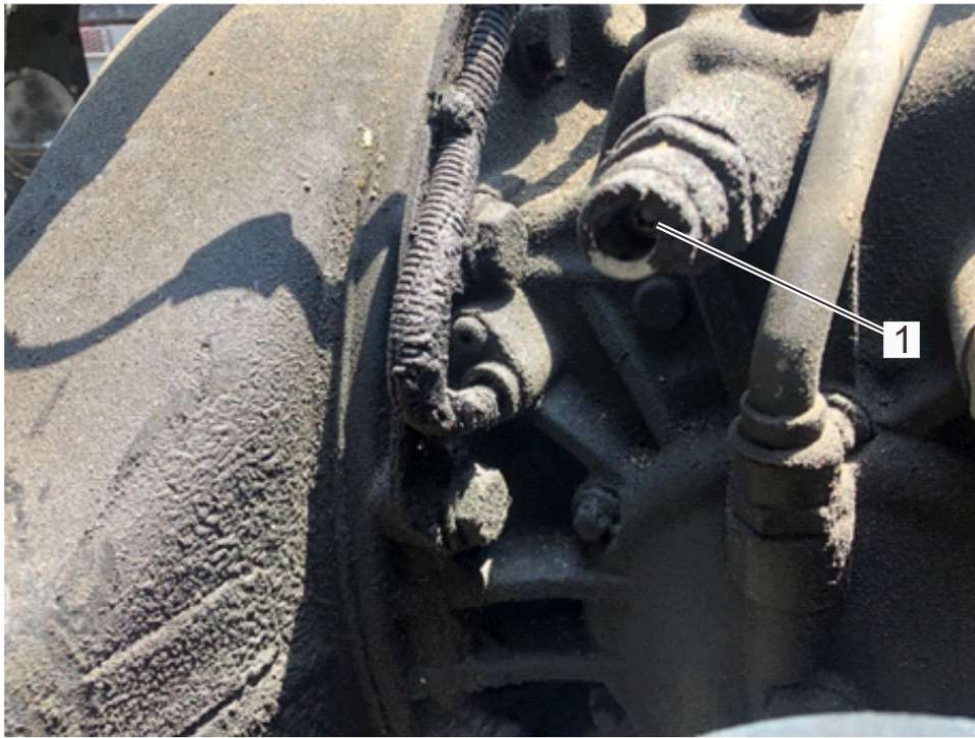
Fig. 1, Bolt Removal

If a vehicle has the signs of oil seepage on the right-hand (RH) side of the rear-rear axle of a 6X4 configuration, it is likely that the shift tool is responsible for this issue. Follow the instruction below to correct the oil leak.

1. Park the vehicle on a level surface, shut down the vehicle, and set the parking brake. Chock the tires.
2. Clean the area around shift tool.
3. Remove the center bolt using a long T30 Torx driver. See Figure 1.

1. Center Bolt
