Technical Service Bulletin

GROUP BODY	NUMBER 24-BD-004H
DATE MARCH 2024	MODEL(S) SANTA CRUZ (NXT)

SUBJECT: TONNEAU COVER INSPECTION, REALIGNMENT, AND ASSEMBLY REPLACEMENT

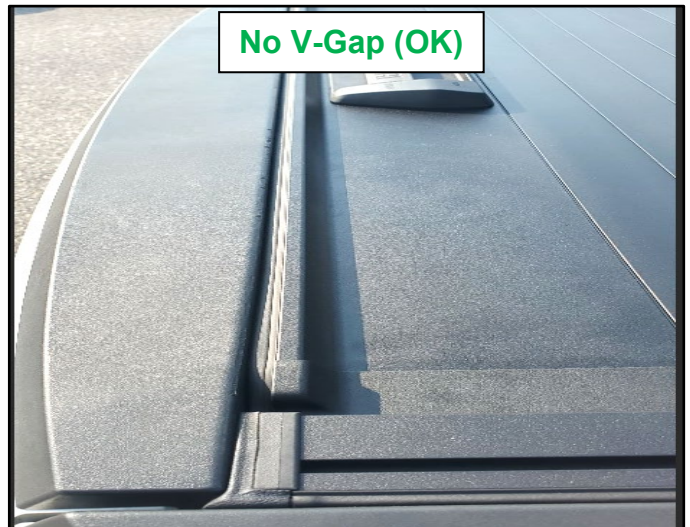
If a V-Gap (B) is present, perform the **Tonneau Cover Realignment** procedure on page 5.

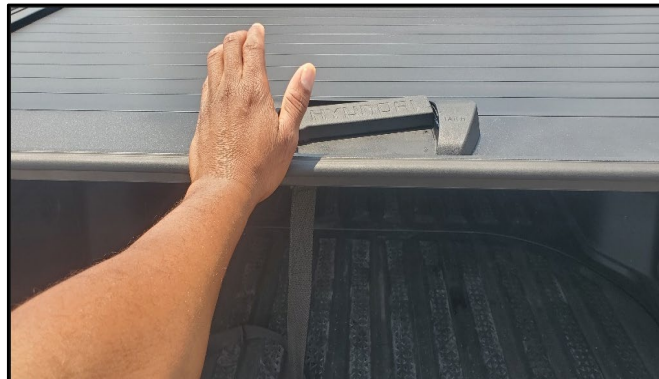
If the tonneau cover does **NOT** retract or requires excessive effort while pushing to retract, perform the **Tonneau Cover Realignment** procedure on the next page.

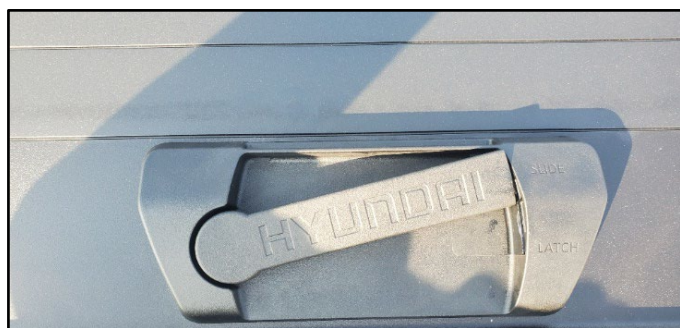
If the V-Gap is still present and/or the tonneau cover is still not retracting after performing the realignment procedure, then replace the tonneau cover assembly.

Refer to the shop manual:

**SANTA CRUZ(NX4A OB) {2022-2024} >
Body (Interior and Exterior) >
Bed Lid > Bed Tonneau Cover Assembly >
Repair procedures**

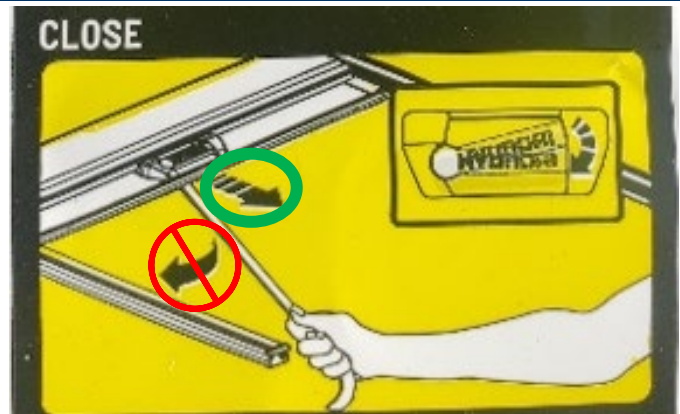
The tonneau cover should only be closed by pulling towards the center.

Only use the pull strap or center handle to close the tonneau cover.

Do **NOT** pull towards the sides or without using the pull strap or center handle.

Alignment/retraction problems may occur if the tonneau cover is repeatedly closed incorrectly.
