GROUP	NUMBER
BODY ELECTRICAL	24-BE-005H
DATE	MODEL(S)
MARCH 2024	ELANTRA (CN7/CN7A)

SUBJECT: FRONT RADAR REPLACEMENT & ADJUSTMENT FOR DTC C1620

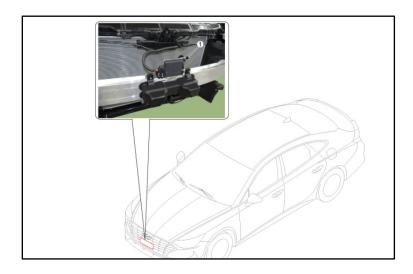
Description: Certain 2021~2022MY Elantra (CN7/CN7A) vehicles may exhibit a warning light with DTC C1620, caused by a distorted signal due to internal contamination of the front radar reception antenna. Customers may also report other systems related to the front radar being inoperative, such as Smart Cruise Control (SCC) or Forward Collision-Avoidance Assist (FCA). Other functions of the Advanced Driver Assistance System (ADAS) are not affected. Follow the procedure in this bulletin to replace the affected front radar unit and perform all related adjustments according to Shop Manual instructions.

DTC Info: C1620 – Forward Collision-Avoidance Assist (FCA) Sensor Calibration/Alignment Error.
