<b>Subject:</b>  LOOSE QUARTER WINDOW GLASS MOLDING	<b>Bulletin No.:</b> 09-015/24
	<b>Last Issued :</b> 03/14/2024

2024 CX-90

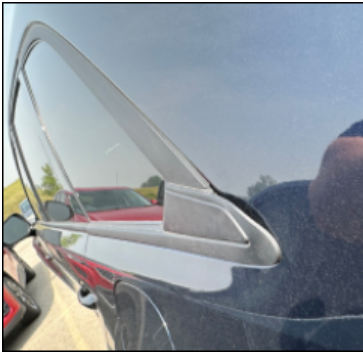
Some customers may complain that the rear side of the quarter window side molding is loose.

This is caused by the quarter window glass molding deforming due to harmful external conditions such as extreme heat or excessive force applied, and the double-sided tape fixing the molding's back side detaches. To eliminate this concern, the double-sided tape has been widened to enhance attachment.

1. Verify the customer concern.
2. Replace the quarter window glass with a new one referring to the instructions in MGSS (QUARTER WINDOW GLASS REMOVAL/INSTALLATION).

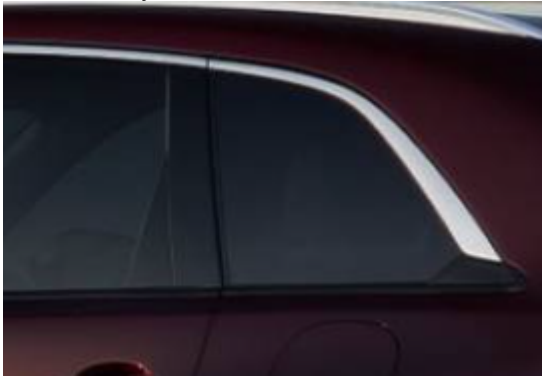
**NOTE:** When installing the quarter glass, pay attention to where it aligns to the rear door beltline molding and the upper molding above the rear window. More than 2 MM misalignment in the horizontal or vertical directions is visible from 2-3 meters away.
