Technical Service Bulletin

Subject: SCRATCH ON SEAT BACK BAR GARNISH FROM CONTACT WITH CONVERTIBLE TOP	Bulletin No.: 09-016/24
	Last Issued : 03/14/2024

2016-2024 MX-5

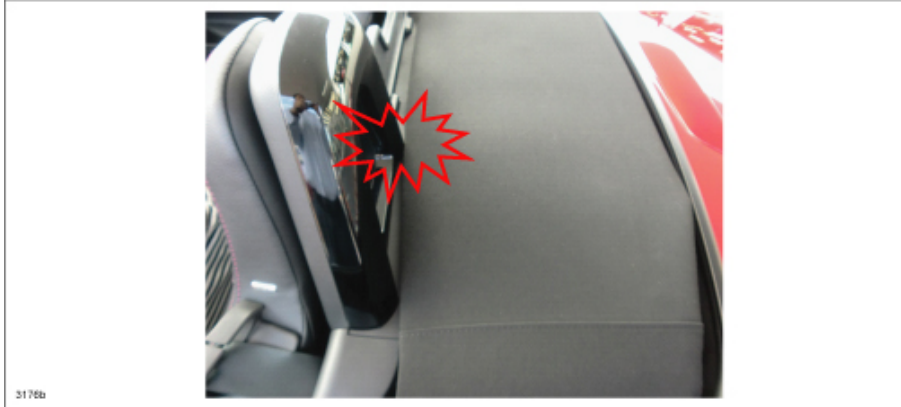
Due to assembly variations, the clearance between the seat back bar garnish and the convertible top is too small on some vehicles.
