Technical Service Bulletin

Subject: RATTLE NOISE FROM B-PILLAR AREA WHILE DRIVING ON ROUGH ROADS	Bulletin No.: 09-017/24
	Last Issued : 03/19/2024

2022 MX-30 with VINS lower than JM1DR*****101035 (produced before April 7, 2022)

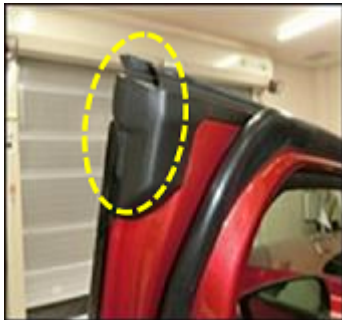
Front-door side

Some vehicles may exhibit a rattle noise near the driver's and/or passenger's head rests at the B-pillar area while driving on rough roads. This is caused by an interference between the rear end of the front door glass run-channel and the front end of rear sash molding.

To eliminate this concern, the front end of the rear sash molding has been modified to reduce the contact friction with the front door glass run channel.

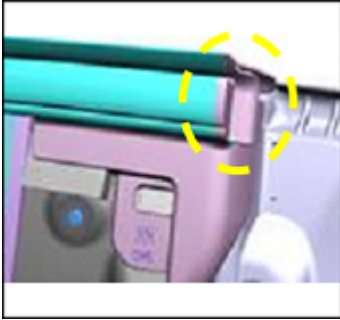
Before the modification

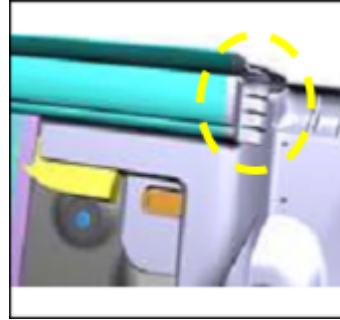
After the modification:
to add ribs at the rear sash molding
