Technical Service Bulletin

Subject: CRACKS ON LEFT AND/OR RIGHT RETRACTABLE HARDTOP QUARTER GARNISH	Bulletin No.: 09-019/24
	Last Issued : 03/26/2024

2016-2023 MX-5 vehicles with Retractable Hardtop with VINs lower than JM1 ND**** ** 561319 (Produced before Nov. 17, 2023)

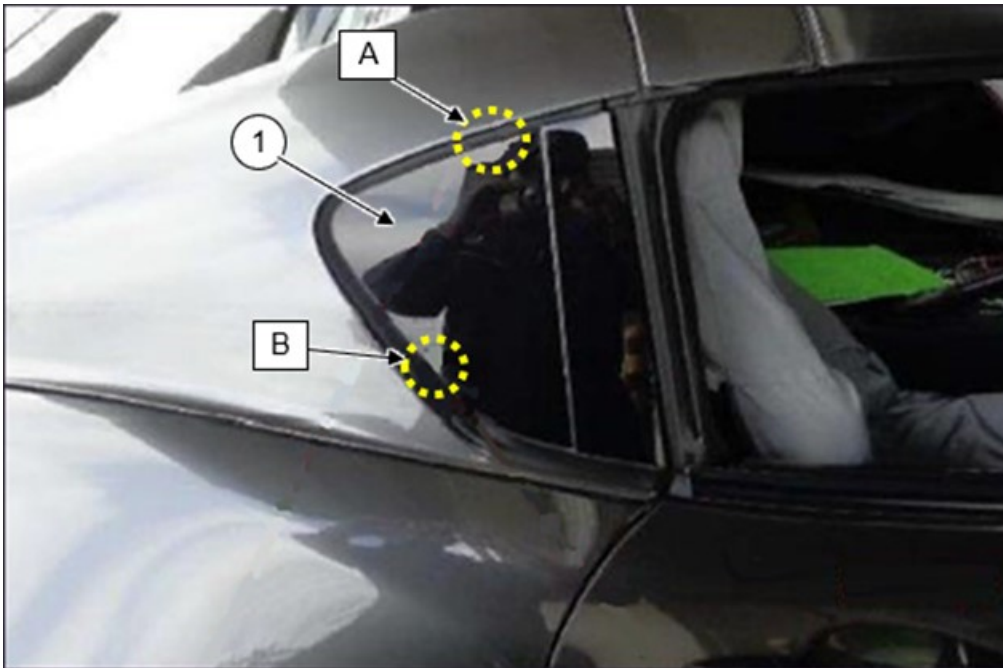
Some vehicles may exhibit crack(s) on the left and/or right side retractable hardtop quarter garnish (1). The molding material on the retractable hardtop quarter garnish may accelerate the deterioration of the quarter garnish, resulting in the cracks. To eliminate this concern, the molding material on the retractable hardtop quarter garnish has been improved.

1. Verify customer concern.
2. Replace the damaged quarter garnish with modified parts according to the instructions on MGSS online QUARTER GARNISH REMOVAL/INSTALLATION.
