## FUEL FILL NECK REPAIR

| <b>Bulletin #(s):</b> | 24-007 | <b>Make(s):</b> | Jayco, Entegra Coach |
| <b>Job Code(s):</b> | <i>If affected unit has warranty remaining, submit your claim following the normal process</i> | <b>Model(s):</b> | Seneca Prestige (37K),<br>Accolade XL (37K) |

| <b>Incident:</b> | Fuel tank is slow filling, cannot use the fuel pump nozzle at high or full volume due to restriction in fuel hose under ABS tank drain pipe. |

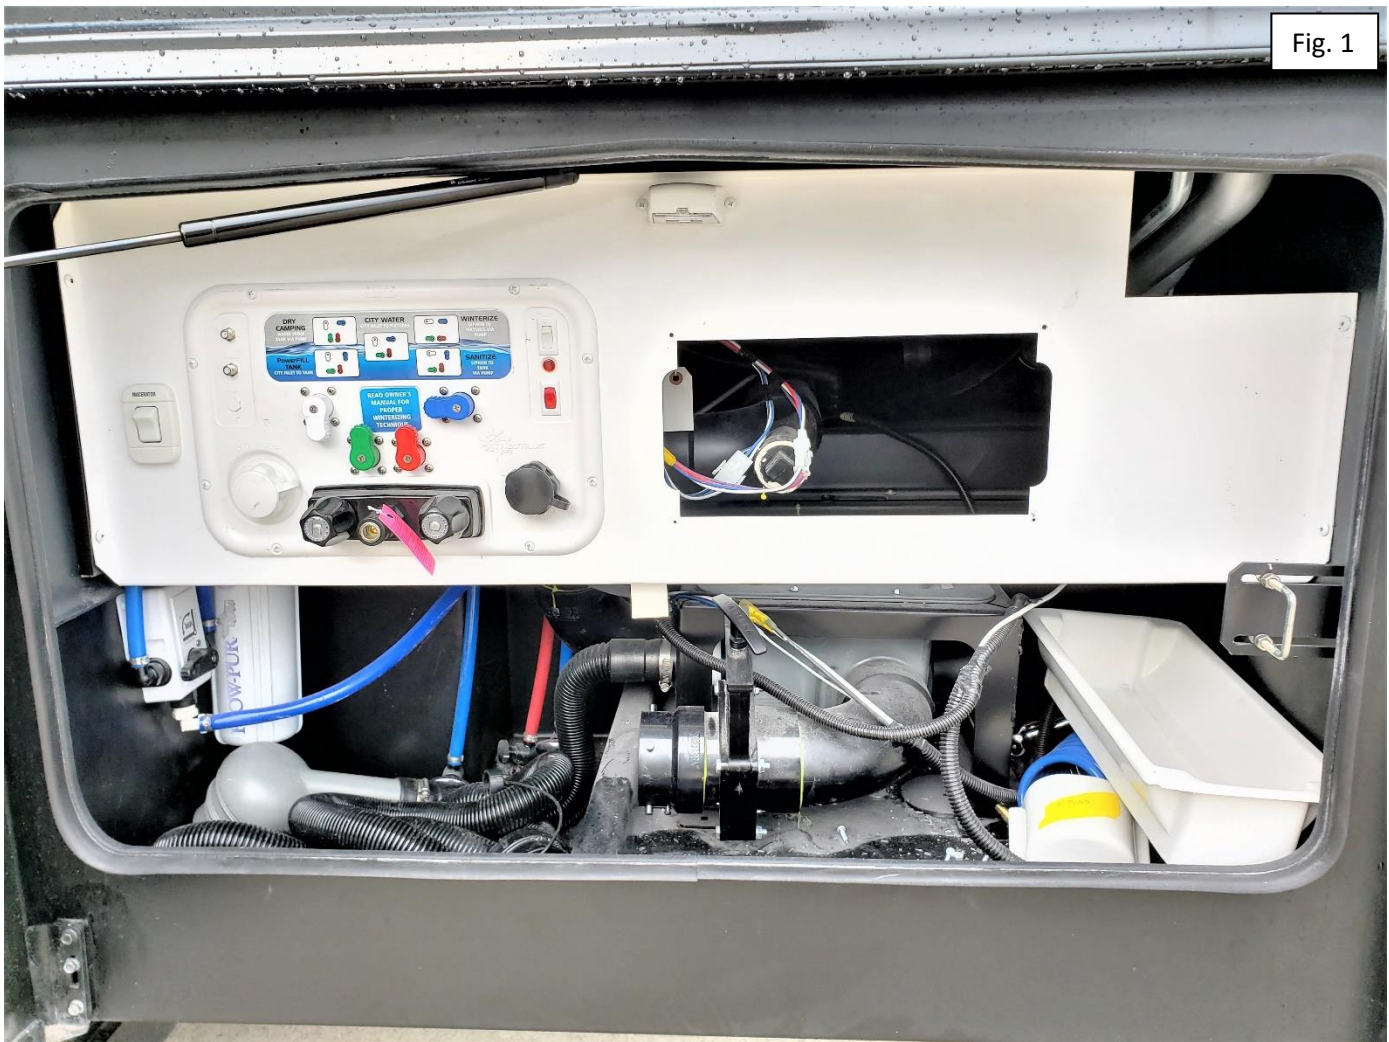
Fig. 1

- Inspect fuel hose for restriction beyond the hose clamp on the metal fill pipe toward the tank in the wet bay. The fill hose will be in line with the fuel fill port on the exterior driver side sidewall of the unit, on the right/rear side of the wet bay. The goal is to relieve the pressure on the hose to restore proper flow.
- Access the fuel fill hose to locate the restriction either by reaching through the towel holder opening or the white water control board. Figure 1 shows the option through the towel holder opening.
