Bulletin #: 2116.3

# Red Warning in the Instrument Cluster: Occupant Seat Belt not Fastened

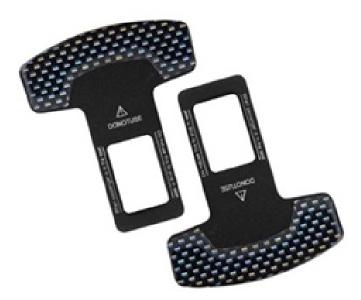
1. Document the presence of any "dummy" seat belt buckles in the vehicle with pictures.

Figure 2: Example of dummy seat belt buckles
