**Complaint – Vehicle Plug does not Lock and the Charging Process Cannot be Started:
Observe Specified Procedure (88/21)**

Revision: This bulletin replaces bulletin Group 2 88/21, dated July 15, 2021.

Model Line: **Taycan (Y1A/Y1B/Y1C)**

Concerns: **Locking mechanism for vehicle charge port**

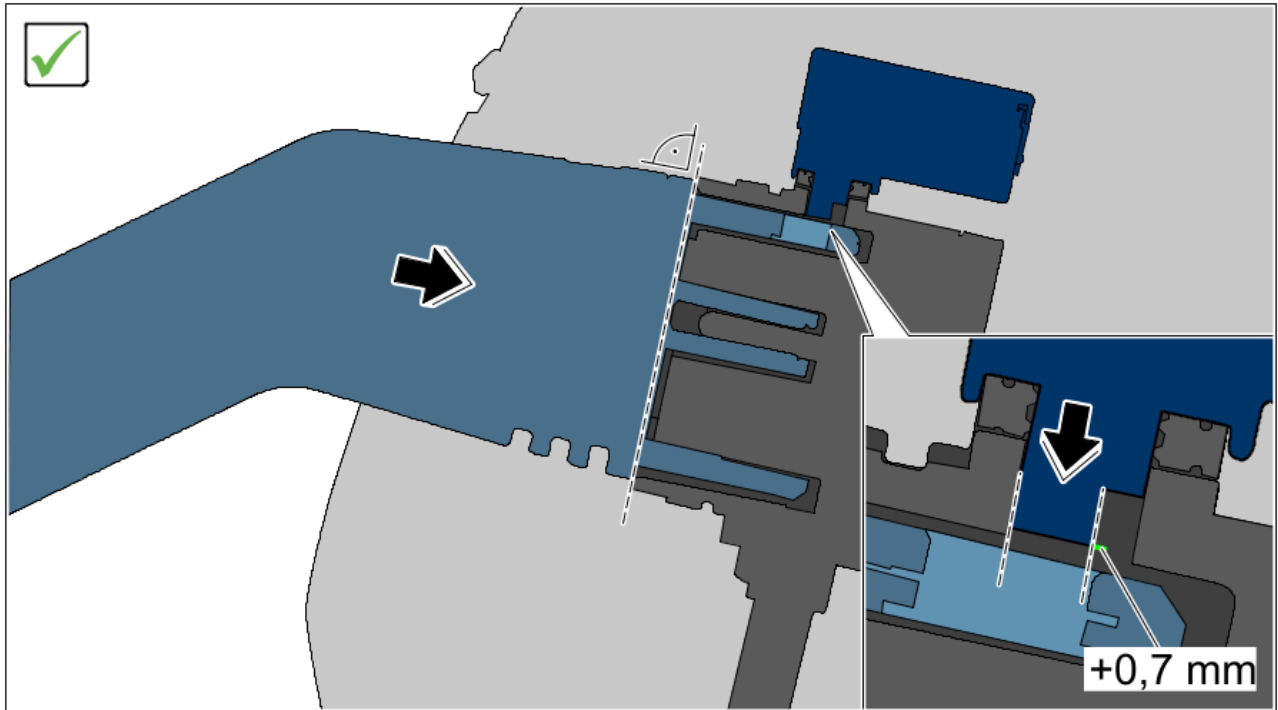
Correct position of vehicle plug

Action required: The vehicle plug must be inserted fully and straight into the vehicle charge connection so that the locking mechanism can engage.

If necessary, the procedure must be repeated and the vehicle plug may have to be held in position by hand.

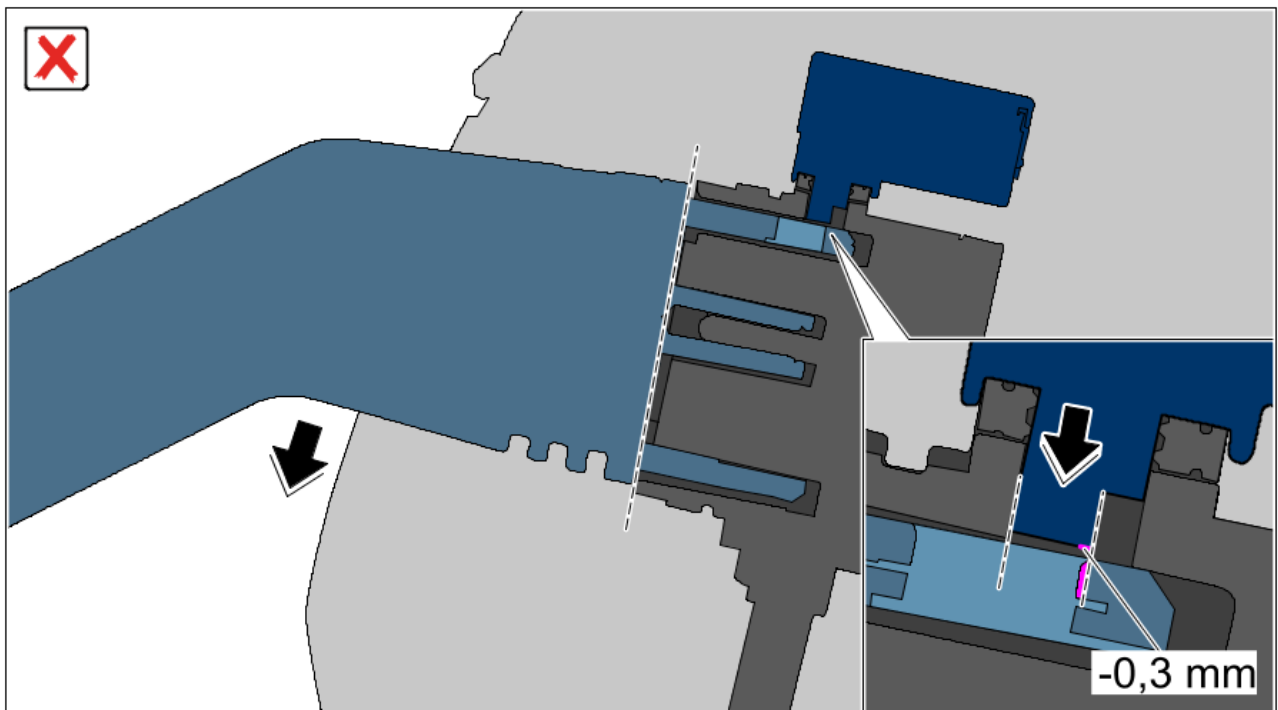
The reason for this is charge connector that is not correctly positioned. As a result, the charging plug cannot be locked and the charging process cannot be started. The use of heavy charging cables/charging plugs can cause this problem.

If the charging plug tilts down even slightly, this can be enough to prevent the actuator from locking the charging plug ⇒ *Incorrect position of vehicle plug.*

Incorrect position of vehicle plug
