**SERVICE BULLETIN**

**APPLICABILITY:** 22-23MY WRX Models **NUMBER:** 15-301-22R  
**SUBJECT:** Reprogramming File Availability for Optimization of Gen 4 Denso CP1 Infotainment Systems **DATE:** 09/09/22  
**REVISED:** 03/15/24

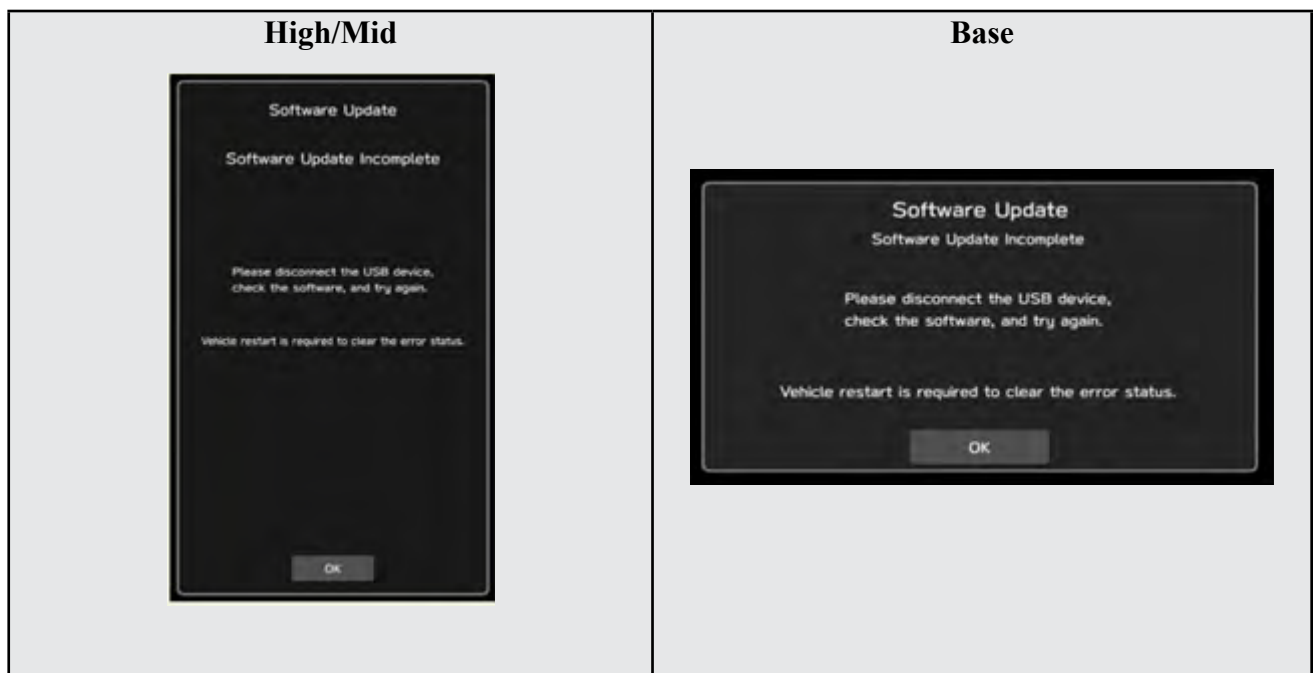
If you get the message **Software Update Incomplete** as shown below, please don't replace the hardware but retry updating the software according to the instructions in "**Appendix B**" on pg. 17.

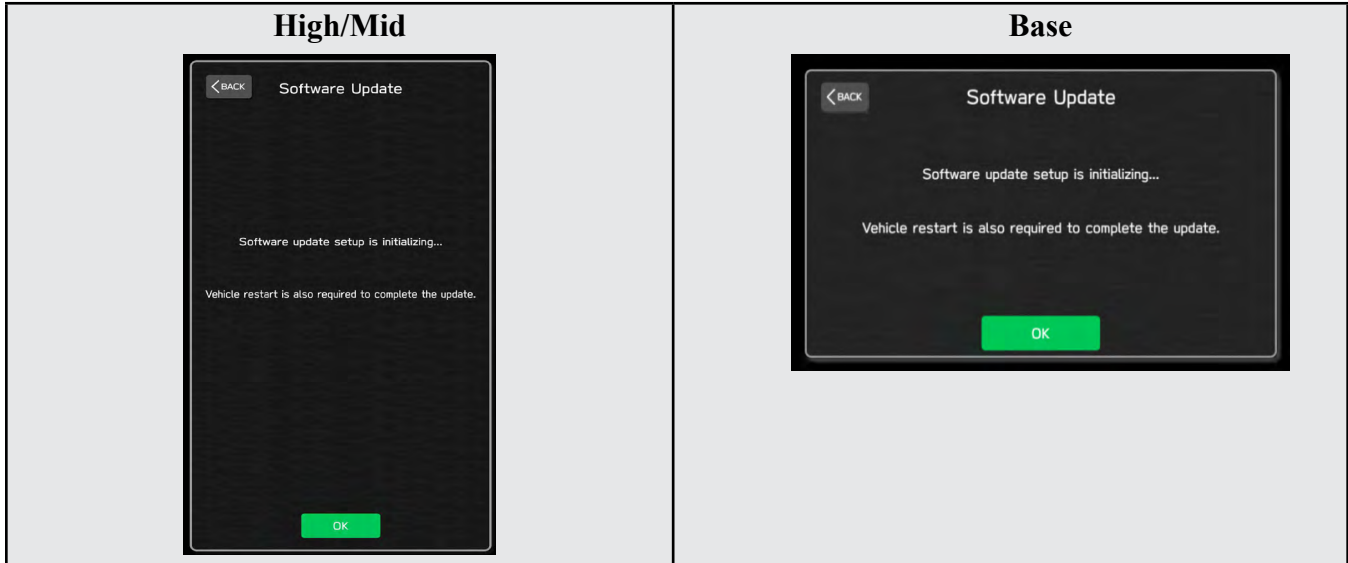
- If the screen shown below appears, **WAIT** for approximately 30 minutes or as long as necessary (waiting for longer than 60 minutes might indicate system malfunction). In that case please perform recovery according to the instructions in “Appendix B ” to allow the Software update setup initialization process to complete.

1. Turn the ignition OFF, open the driver’s door, close the driver’s door and **WAIT** for 3 or more minutes before proceeding further.
2. Open the driver’s door again and either turn the ignition ON (if a charger is connected) or start the engine.
3. Go to Dealership Mode menu again (PRESS and HOLD the RIGHT-side temperature control buttons (both up and down) and press the Tune / Scroll knob 6 times then release all to display the Dealership Mode) and select Software Update as in **STEP 4c** beginning on pg. 10.

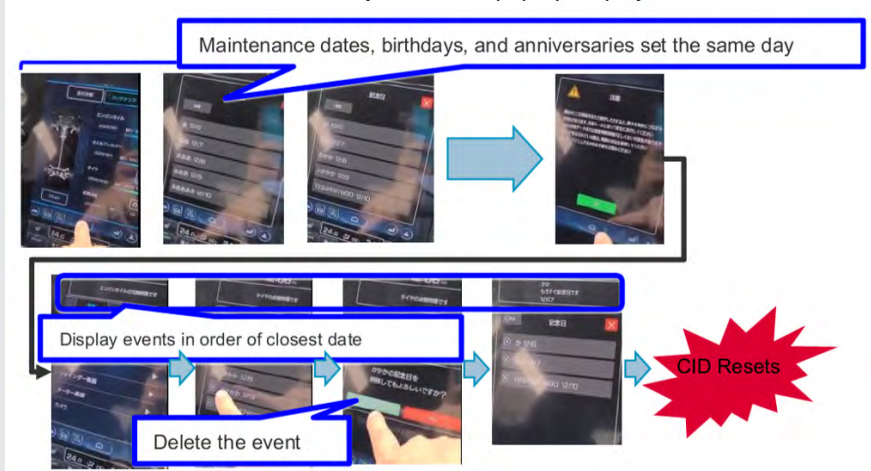
Number	Symptoms to be Improved:
<p><b>10</b></p>	<p><b>If a same date is set to maintenance date, birthday, and anniversary date, pop-ups will appear in sequence on the top of the CID after engine is started when the day comes. Under this condition, if an operation is performed to delete the maintenance date, birthday or anniversary date registration within a few seconds immediately before the pop-up display, the CID screen will reset.</b></p>

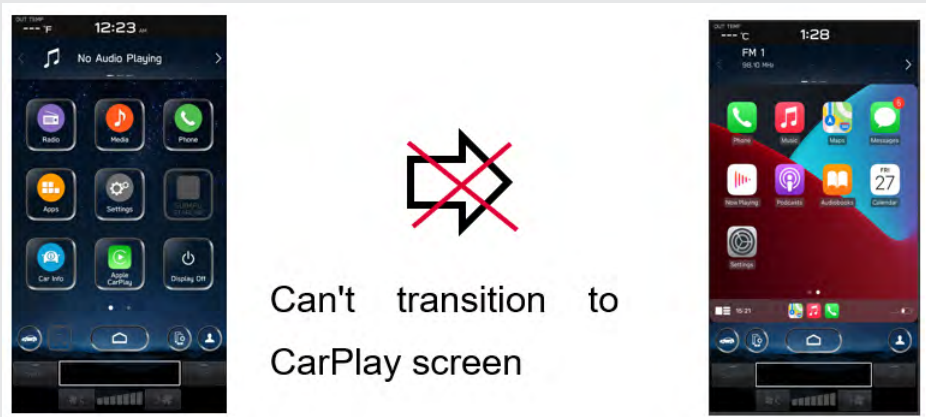
<p><b>14</b></p>	<p><b>When the engine is started with the iPhone connected via USB, CarPlay does not start even if the CarPlay icon on the home screen is pressed.</b>  <b>&lt;Hint&gt; This can be resolved by reinserting the USB cable.</b></p>

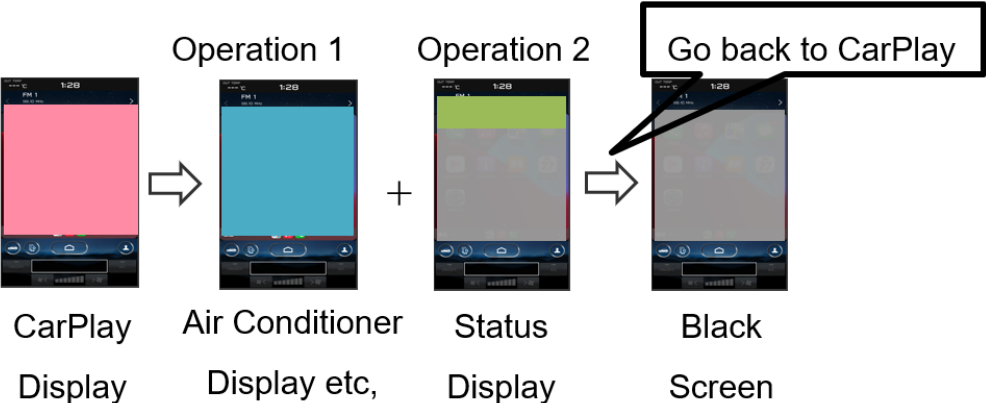
Number	Symptoms to be Improved:
<p><b>15</b></p>	<p>After performing operations 1 and 2 below from the CarPlay screen, returning to the CarPlay screen causes the CarPlay screen to be black screen.  <b>Operation 1: Switching to a pop-up screen such as the air conditioner screen</b>  <b>Operation 2: Interrupt pop-up screen display due to volume operation, etc.</b></p> <div style="text-align: center;">

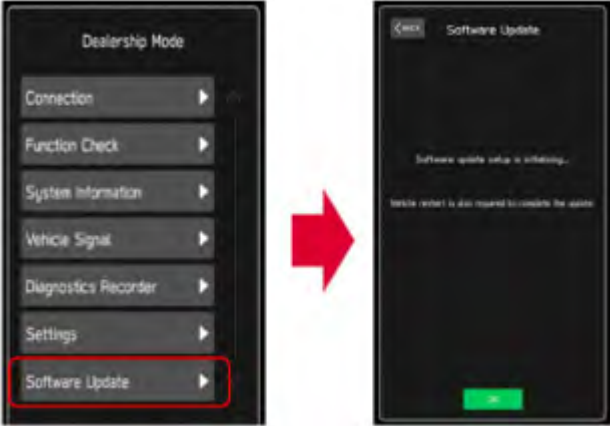
<p>Insert USB      Tap OK      Confirmation screen      Error screen</p>
13	<p><b>When “Software Update” is selected in the Dealership Mode, the following initialization process does not end more than 20 minutes. *</b></p>

<p><b>Note*</b> In case this USB update failure occurs, retry updating according to the instructions in “Appendix A”</p>
14	<p><b>When the FOTA pop-up (new software availability notification) is displayed while the CarPlay is being used, the display comes back to CarPlay screen even if the customer tries to get into the FOTA screen.</b></p>
