PRODUCT CAMPAIGN BULLETIN

APPLICABILITY: 2021MY Crosstrek
 2022MY Forester
 2021-23MY Legacy
 2021-23MY Outback

NUMBER: WRQ-23R

SUBJECT: Safety Recall – Transmission Inhibitor Switch Replacement

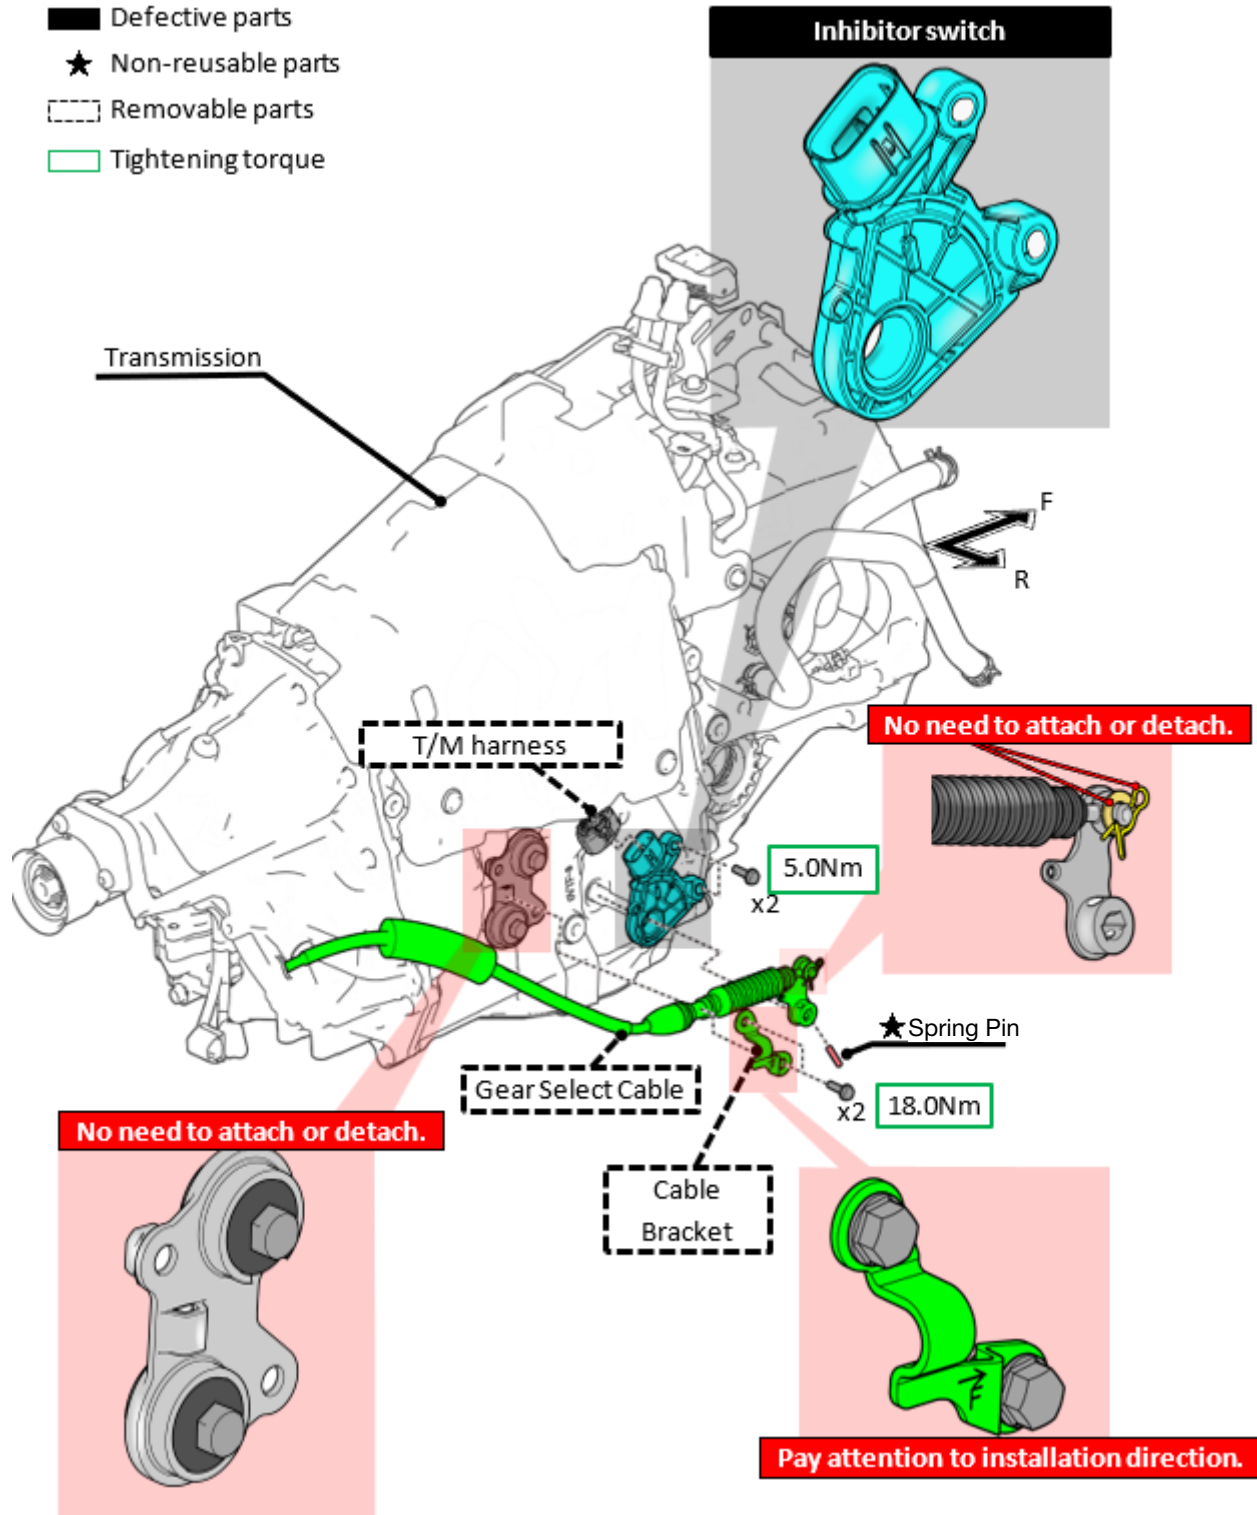
COMPONENT CONFIGURATION:

The vehicles included in this recall may contain an inhibitor switch that was manufactured with an insufficient weld between the switch stator and cover which may allow water intrusion.

Over time, moisture intrusion may cause the inhibitor switch to become inoperative. An inoperative inhibitor switch may result in the backup lamps not illuminating when in reverse gear, the rear-view monitor not displaying, the transmission gear select indicator in the instrument panel not being displayed, or inability to start the engine.

For all the potentially affected vehicles, Subaru dealers will replace the inhibitor switch with a new one at no cost to the customer.

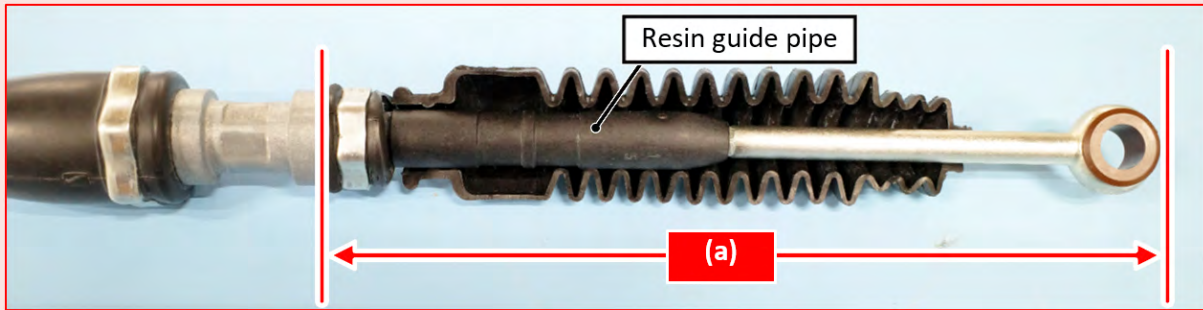
DO NOT apply an impact or a load to part (a) of the gear selector cable shown in the picture below. Doing so may damage the resin guide pipe inside the boot.

Due to the resin guide pipe and the inner cable being unable to be seen, **CAREFULLY** remove and install the gear selector cable.

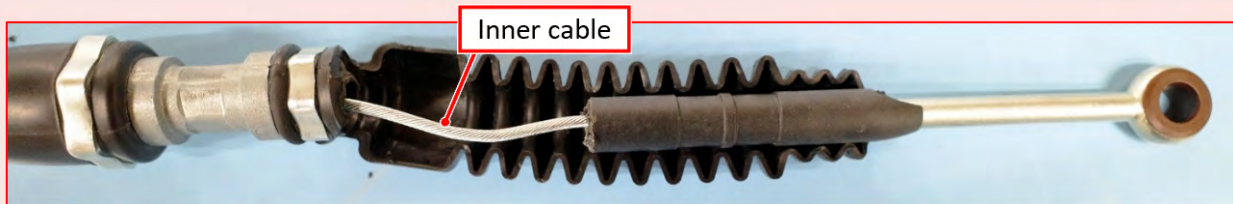
If the resin guide pipe is damaged, the inner cable can become slackened when operating the gear selector lever and the shifter arm become inoperative. As a result, the shift positions of the gear selector lever and the inhibitor switch do not match, causing malfunctions such as an engine no crank/no start condition.

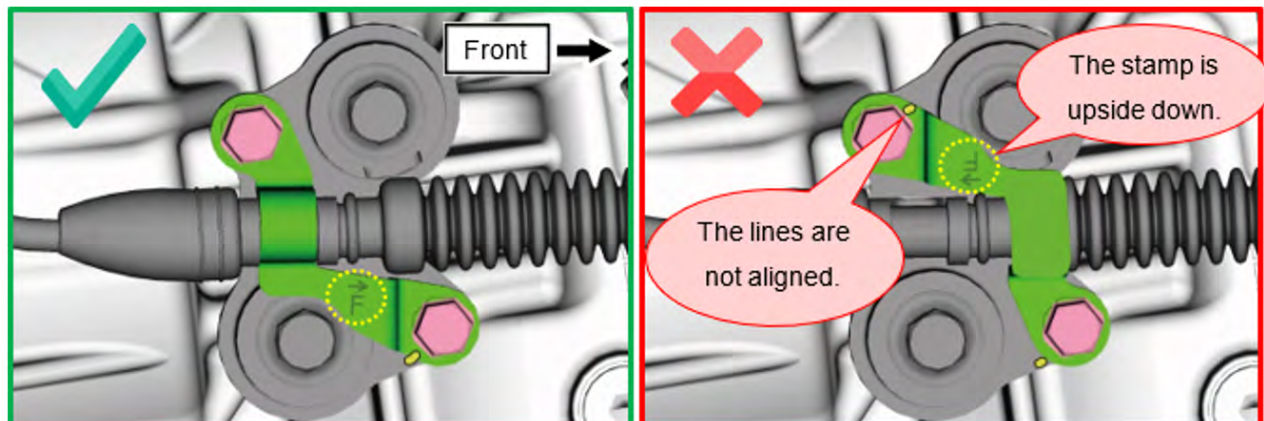
CAUTION: DO NOT install the cable bracket in the opposite position. Doing so will damage the gear selector cable.

STEP 20: Install the cable bracket using the alignment marks made in Step 13. Torque the mounting bolts to 18Nm (13ft-lbs.).

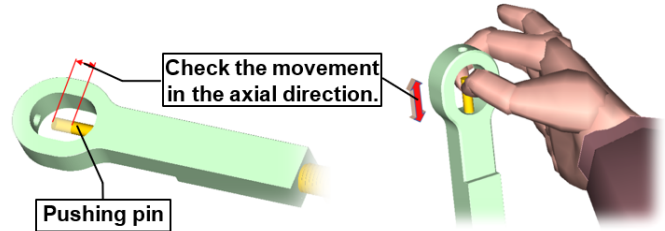
1. CHECKING BACKLASH OF THE PUSHING PIN

Pinch the pushing pin between your thumb and index finger and move it in the axial direction to check the backlash of the pushing pin.

→ If there is no backlash, proceed to step 2.

→ If there is backlash, the pushing pin is NOT retained properly. Proceed to step 3.

Using a 4mm allen wrench, CAREFULLY tighten the retaining screw in the clockwise direction until the size of the gap between the tip of the pushing pin and the tool body is 1mm or less.

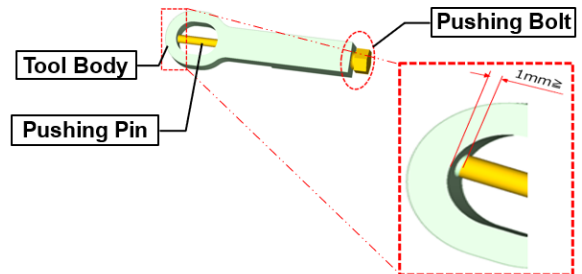
2. CHECKING THE INSTALLATION CONDITION OF PUSHING PIN

Fully turn the pushing bolt in the clockwise by hand until it stops. Inspect the size of the gap between the tip of the pushing pin and the tool body.

→ If the gap is 1mm or less, the pushing pin is retained properly.

→ If the gap is larger than 1mm, the pushing pin is NOT retained properly. Proceed to step 3
