SERVICE BULLETIN

APPLICABILITY: 2022MY Forester

NUMBER: 07-209-22R

SUBJECT: EyeSight® Reprogramming
 DTC B28A6 Internal Stereo Camera
 Communication 1

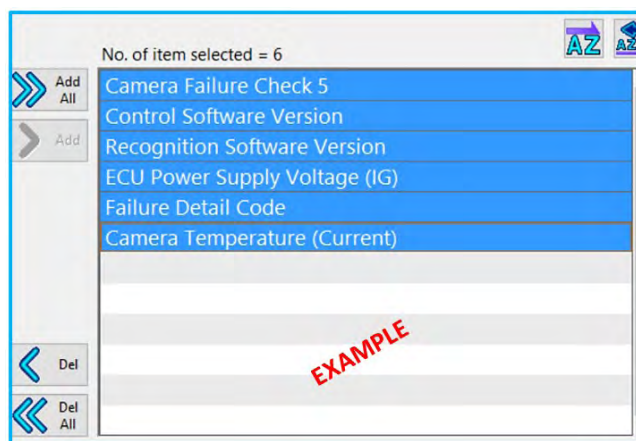
STEP 2: Confirm the following Data Monitor Values prior to any attempt to reprogram:

- 1. Camera Failure 5 is “**0000000B**”
- 2. Control Software Version is “**0421011E**”
- 3. Recognition Software Version is “**07210004**”
- 4. ECU Power Supply Voltage (IG) is **13.5 Volts**
- 5. Failure Detail Code is **C213**

NOTE: If Failure Detail Code C213 is not displayed, check the fault freeze frame data (FFD) of B28A6. If C213 is listed in the FFD, the parameter has been met.

- 6. Camera Temperature is **less than 176 degrees Fahrenheit (80 degrees Celsius)**

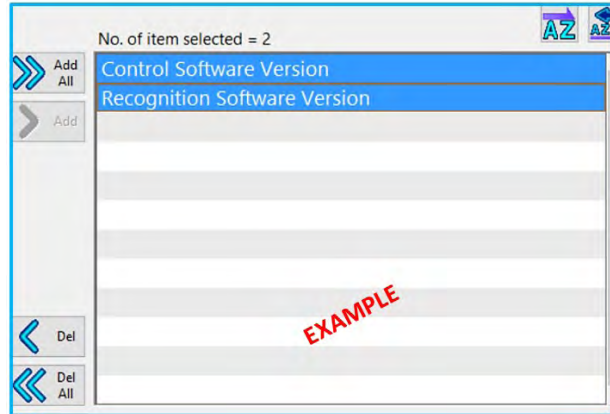
STEP 2: Confirm the following Values:

- 1. Control Software Version is “04210801” or “0420802”
- 2. Recognition Software Version is “07210802” or ”07210803”
