# Technical Service Bulletin

<b>Subject:</b>  REAR BRAKE NOISE	<b>Bulletin No.:</b> 04-001/24
	<b>Last Issued :</b> 03/04/2024

2019-2024 Mazda3 (Japan built)  
2019-2024 Mazda3 (Mexico built)  
2020-2024 CX-30  
2022-2023 MX-30

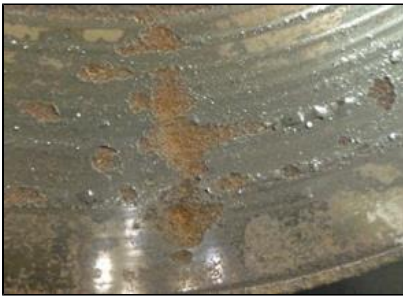
Sample case: if lathe is not applicable.

Some areas of the surface have fallen off due to rust and are too thin.

1. Verify the customer concern.
2. Check the disc surface to see if the cause of noise and vibration is the disc's rust (Some areas of the surface have fallen off due to rust and are too thin, which may look like black stains on the surface). If rust is the cause of the noise or vibration when applying the brake, lathе disks on-vehicle, or replace them with new ones and replace the brake pads.

- Check the disc thickness using a micrometer before lathing, if the thickness is below 8.7 mm for 2WD or 9.7 mm for AWD, replace the disc (DO NOT lathе). Measure the thickness in the relatively less rusted area where the pads are hitting but not in the severely rusted area.
- Disc replacement is acceptable if an on-car lathe machine is not available.

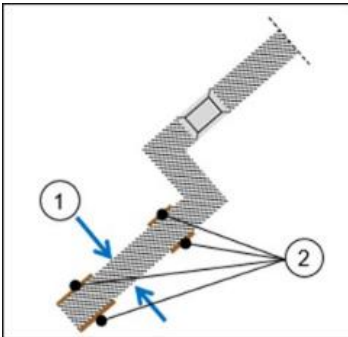
SECTION A-A

**NOTE:** Measure the thickness at the least rusted area.

- (1) Measuring points  
(2) Rust

3. After lathing the disc, re-measure the disc thickness. Replace the discs if the thickness is below the machining limit of 7.8 mm for 2WD and 8.8 mm for AWD as well as the brake pads. Refer to the instructions in MGSS:
