## Display of “Coolant temperature too high” in Group V6 and V8 Engines

### Vehicles Affected

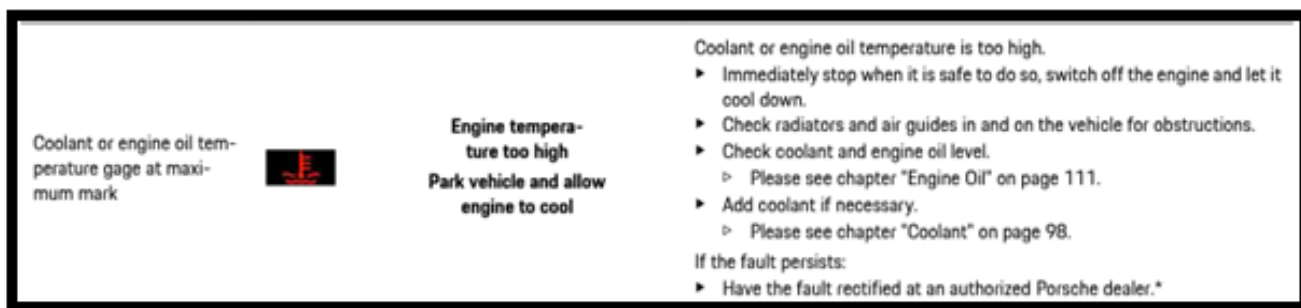
Customer complains about “Coolant temperature too high” warning message, Instrument Cluster fault code B19A750.

Figure 1 - Owner's Manual Information for Over-Temperature Warning (B19A750)

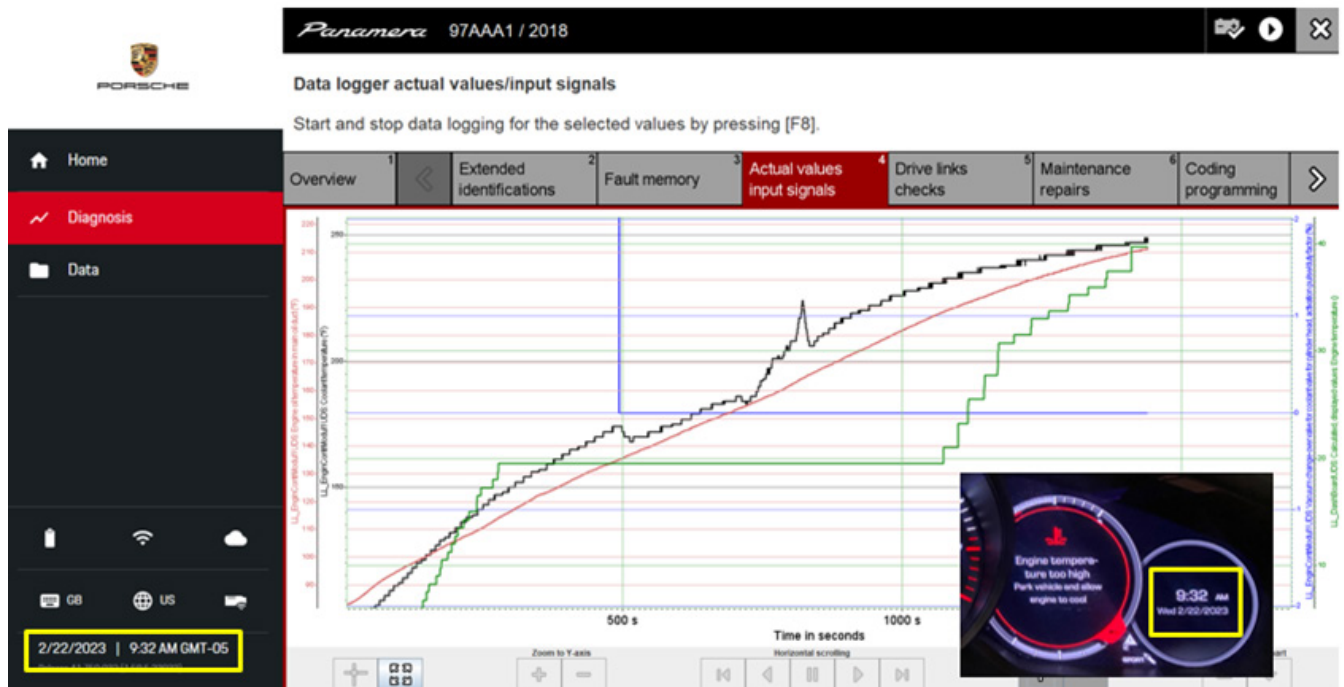
The aforementioned warning message in the instrument cluster (IC) only displays when the coolant temperature exceeds the warning threshold. The vacuum changeover valve controlling the water pump's sleeve in the aforementioned engines is known to intermittently stick, thus causing the overheat warning in the IC.

Figure 2 simulates an overheat condition by overriding the changeover valve for the coolant pump sleeve. For this simulation, the valve's electrical connection to the DME remained intact, but the simulation removed the valve from the vacuum lines, forcing the coolant pump's sliding sleeve to remain in the blocked flow position (no coolant circulation). Thus, the simulation's data of Figure 2 shows a 'forced' overheat condition from cold-start. In this simulation, the DME commands the changeover valve to switch, opening the pump's sleeve, allowing coolant to circulate (if the valve was connected). The blue series line shows this switch around 500 seconds of engine run time. Because the valve is not in-line with pump's vacuum supply (removed except electrically), the sleeve never opens, and the IC warning "Display of coolant temperature too high, active" results after approximately 25 minutes.

Figure 2 - Tester Tracing of Forced Overheating from Overridden Water Pump Changeover Valve

Please follow the function test as outlined in "TI, 1950 Warning Message "Coolant Temperature Too High": Checking Coolant Pump and Change-Over Valve (173/21)" The vacuum changeover valve controlling the water pump's sleeve in the aforementioned engines is known to intermittently stick, thus causing the overheat warning in the IC. Therefore, it is imperative to check its function as thoroughly as possible under various temperature conditions, because temperature can play a role in its behavior.

Please follow the referenced TI and appropriate workshop manuals for any work deemed necessary.
