SERVICE BULLETIN

APPLICABILITY: 2014-18MY Forester

NUMBER: 17-19-24

SUBJECT: DTC B1760 Occupant Detection Sensor Mat /
Diagnosis & Repair Procedures

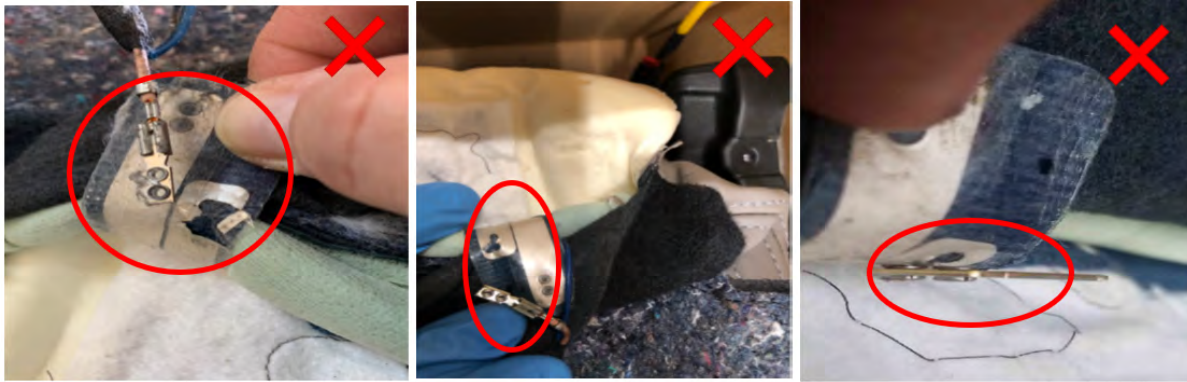
- Because the female connectors on the harness have strong clamping power, supporting the male connectors as described is mandatory to prevent any excessive bending of the sensor mat connectors and **CRITICAL** to preventing sensor mat damage as shown in the photos below.

- **NEVER** bend or twist the sensor mat connection point, especially while disconnecting or reconnecting the harness connectors as doing so will damage it.

These three photos are examples of a sensor mat connection point damaged due to overly-aggressive disassembly. This **MUST** be avoided.

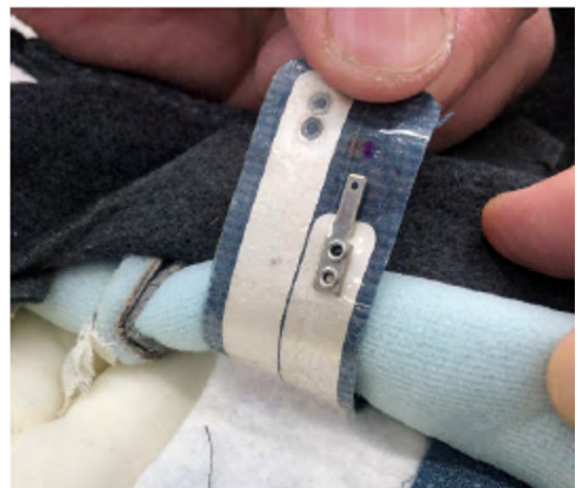
STEP 8: **IMPORTANT:** Before connecting the new harness, inspect the tail and sensor mat connectors to confirm they are tight on the 2 metal bands of the mat. Inspect closely for any breakages, cracks or other damages to the visible components of the sensor mat. If any damage is identified, the complete seat cushion assembly must be replaced as the sensor mat is not a serviceable component.

REMINDER: If a replacement is necessary, always order the most up-to-date seat cushion assembly part number for the VIN being repaired.
