SERVICE BULLETIN

APPLICABILITY: 2020-24MY Legacy & Outback
2023-24MY Ascent

NUMBER: 07-213-22R

SUBJECT: Genuine Battery Replacement

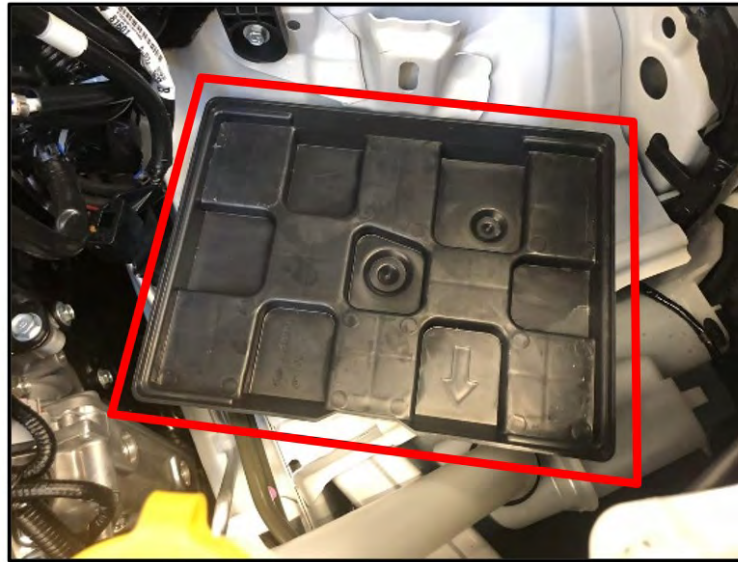
STEP 3: Replace the original battery tray with the new part (p.n. 82190AN000).

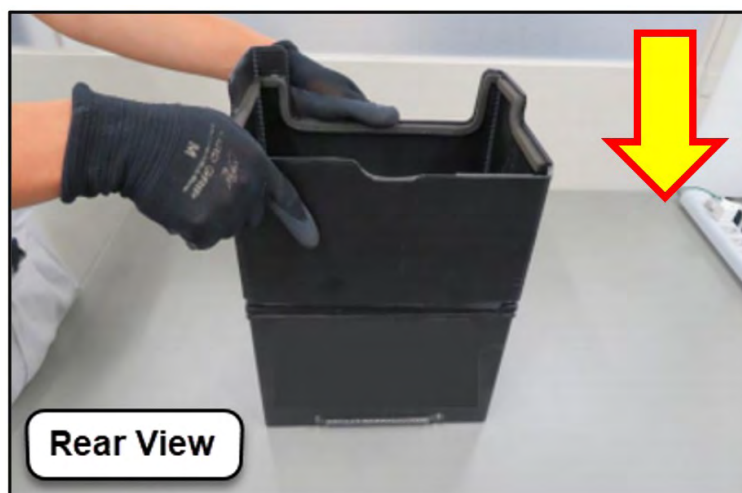
STEP 4: Install the original battery cover to the new replacement battery. Confirm the bottom of the cover is aligned flush with the bottom of the battery.

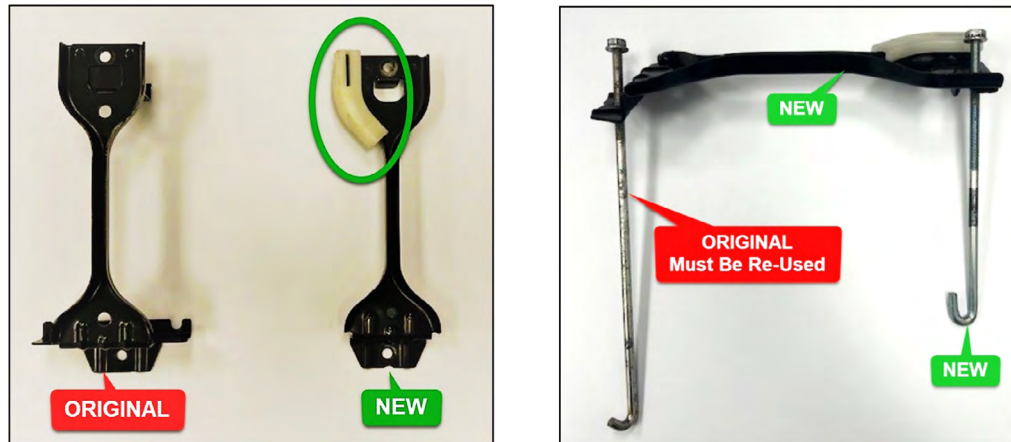
STEP 5: Assemble the new battery holder (p.n. 82184SG000), NEW rear holding rod (p.n. 82161SJ000), and the ORIGINAL front holding rod as shown below. The original rod nut can be transferred to the new rear holding rod.

IMPORTANT: DO NOT discard the original holder and rear rod. These parts are to be returned to the customer.

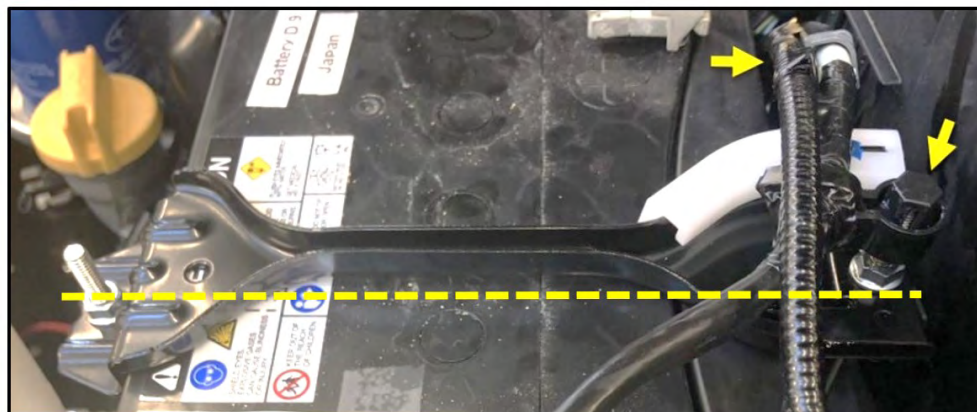
CRITICAL: Confirm the battery holder is center mounted with the battery cables secured and routed correctly.

STEP 7: Install the battery holder and holding rods on to the battery.

- A. Torque the two holding rod mounting nuts to **3.5 N·m (2.6ft.-lbs. or 31inch.-lbs.)**.
- B. Torque the positive terminal to **6 N·m (4.4ft.-lbs. or 53inch.-lbs.)**.
- C. Torque the negative terminal to **7.5Nm (5.5ft.-lbs. or 66inch.-lbs.)**.
- D. If the battery sensor is removed or disconnected torque to 7.5Nm (5.5ft.-lbs. or 66inch.-lbs.) while supporting the sensor with the other hand as outlined in the applicable Service Manual under: STARTING/CHARGING SYSTEMS > Battery Sensor.
