Technical Service Bulletin

87 Air conditioning refrigerant circuit diagnostic method using calibration gas

87 24 70 2064077/4 March 29, 2024. Supersedes Technical Service Bulletin Group 87 number 23-60 dated October 23, 2023 for reasons listed below.

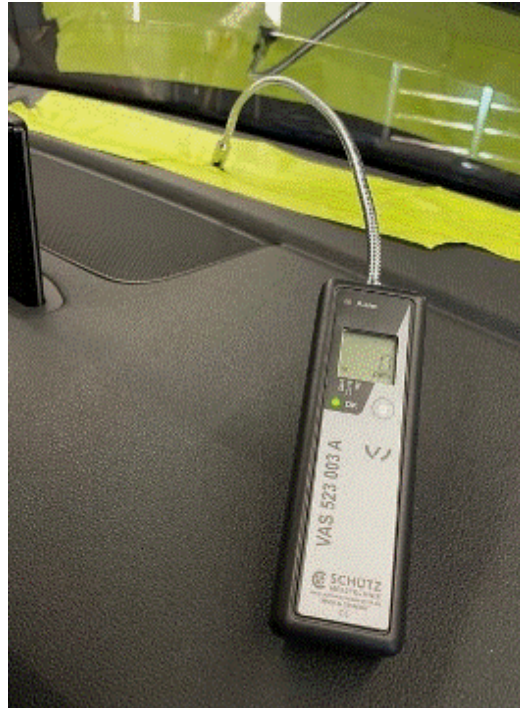
Figure 6. VAS 523003A gas leak detector in place in the defroster outlet.

10. After the circuit is charged allow the circuit pressure to equalize for 20 minutes. Leak detection can then begin.
11. Close off the defroster outlets with masking tape leaving a small opening for the VAS 523003A gas leak detector probe (Figure 6).

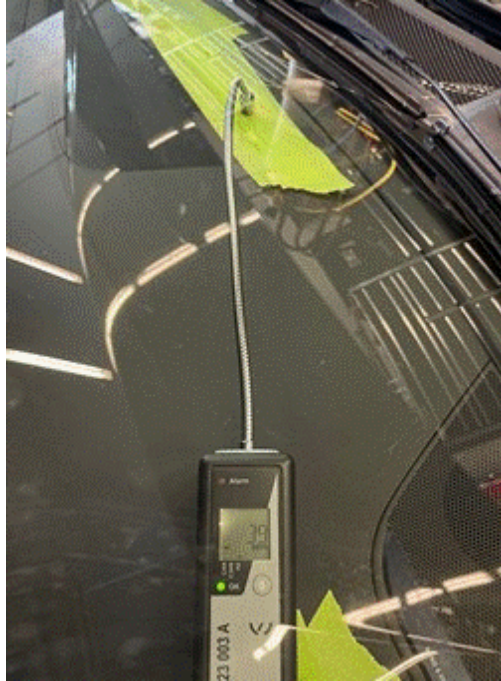
12. The gas leak detector VAS 523003A reacts to the hydrogen component in the calibration gas. Since hydrogen is lighter than air, it will rise to the position of the detector probe. The hydrogen content in the calibration gas, however, evaporates after a short period of time (Figure 7).

Figure 7. VAS 523003A in place in the defroster outlet and hydrogen presence is detected.

Perform the leak diagnosis immediately after charging the refrigerant circuit with calibration gas and the 20-minute equalization period. Depending on the conditions, it may be necessary to recharge the refrigerant circuit with calibration gas in an attempt to clearly identify a circuit leak at the evaporator core.

13. If no leak is detected through the defroster outlet using this method the evaporator core is not the source of the refrigerant leak and the evaporator core is not to be replaced. Continue diagnosis using the VAS 523003A along all remaining components of the refrigerant circuit to determine the source of the leak.
14. When any and all leak sources have been identified close the valve on the top of the calibration gas tank. Any calibration gas that remains in the refrigerant circuit can be slowly ventilated until the circuit pressure has equalized with atmospheric pressure. Proceed with the necessary repairs, evacuate the refrigerant circuit, and recharge the system as necessary.

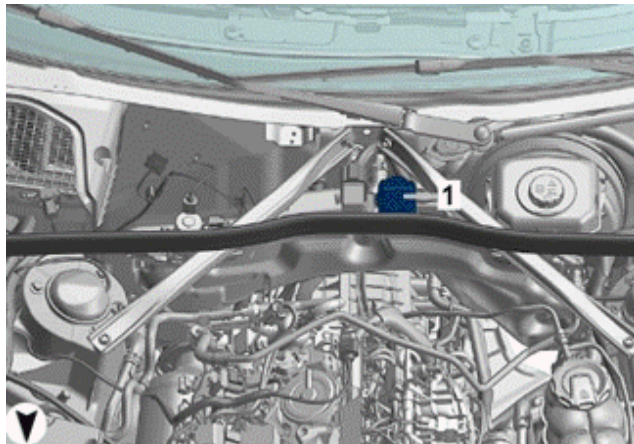
Figure 8. Relay and fuse carrier 3 -SR3-.

and Fuse Carrier 3 precisely will result in water intrusion and subsequent component damage.

15. **NOTICE**
- Should the evaporator for the Q5 be confirmed leaking by way of this diagnostic procedure and replacement of the evaporator is performed it is necessary to loosen and refasten the Relay and Fuse Carrier 3 -SR3- (shown in figure 8, position 1) in the course of the repair. During reassembly of the vehicle it is **critically important** that this relay and fuse carrier in particular be reinstalled in its correct original position. Failure to reinstall the Relay
