Outer Body Symptom – Whistling Noise from the Area of the Cowl Frame A-Pillar and Roof at Speeds Greater than Highway Speeds (SY 19/24)

Model Line: **Taycan (Y1A / Y1B / Y1C)**

Model Year: **As of 2022 up to 2024**

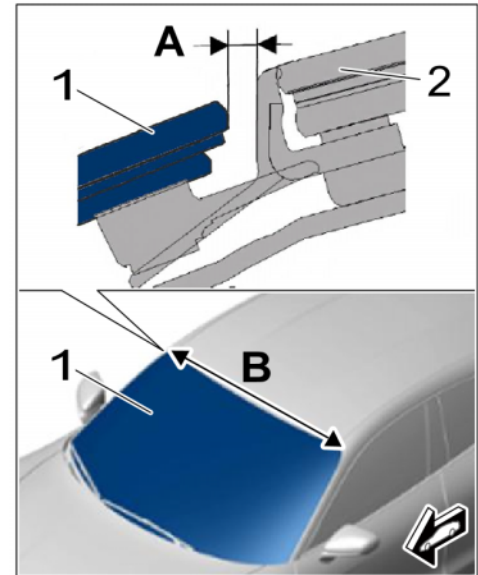
Gap between windshield and roof

Cause: A joint that is too large between the windshield and glass roof at the level of the A-pillar can lead to insufficient preloading of the sealing lip of the joint seal, thereby causing noises.

Work Procedure: 1 Determine distance ⇒ *Gap between windshield and roof* -**A**- between windshield ⇒ *Gap between windshield and roof* -**1**- and roof module ⇒ *Gap between windshield and roof* -**2**- (gaps between the cowl frame and roof) at **multiple points** over entire length ⇒ *Gap between windshield and roof* -**B**- using a feeler gauge.

Assessment	Action
Distance ⇒ <i>Gap between windshield and roof</i> - A - is at most 3.8 mm/ 0.15 in throughout.	The complaint is not due to too large a distance between the windshield and roof module and must be localized elsewhere. End of remedial action.
Distance ⇒ <i>Gap between windshield and roof</i> - A - is in places or continuously greater than 3.8 mm/ 0.15 in .	Replace windshield. For instructions, see: ⇒ <i>Workshop Manual '641219 Removing and installing windscreen'</i> IMPORTANT: Glaze the new windshield along the A-pillar higher in order to create a smaller distance (within the tolerance limits) between the windshield and roof module. and finally Go to ⇒ 2.

2 Once the adhesive has hardened, check again whether the distance between the windshield and roof module is **at most 3.8 mm/ 0.15 in** over the entire length.
Observe additional joint dimensions according to repair instructions: ⇒ *Workshop Manual '6X00IN Gap dimensions'*
