**Surround View Camera Intermittent Operation**

Models	Model Year	Model Type	VIN Range	Vehicle-Specific Equipment
Taycan	As of 2020 up to 2024	Y1A, Y1B, Y1C	N/A	KA6

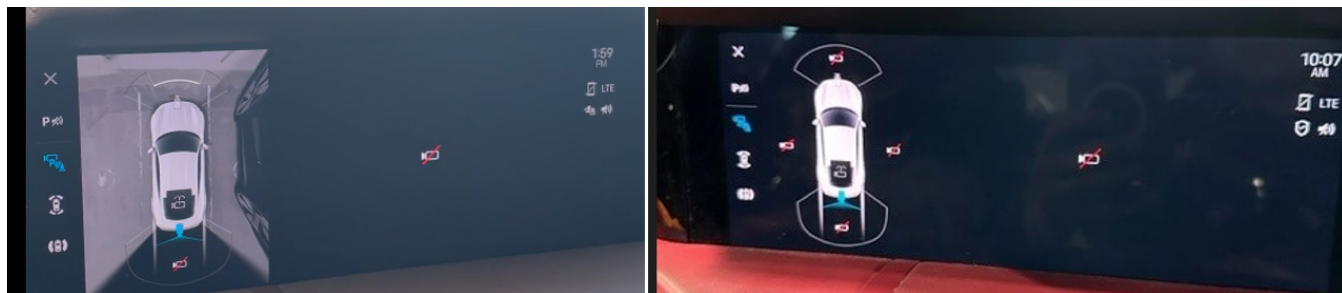
Figure 1- Failure Modes

The customer complains of intermittent operation for one or multiple surround view cameras that appear blank with a crossed-out camera icon for each failed camera.
