CADILLAC
DCS6842
URGENT - DISTRIBUTE IMMEDIATELY

Subject: UPDATE: N232428540 - Customer Satisfaction Program
Multiple Module Reprogramming
Population Expansion

Models: 2023 Cadillac LYRIQ

N232428540 Multiple Module Reprogramming

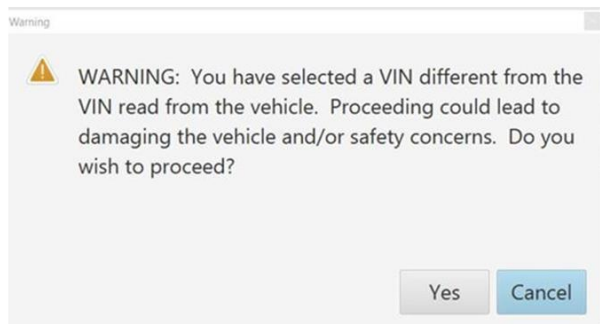
5877000

Important: If the vehicle VIN DOES NOT match, the message below will be shown.
